PROPERTY INSPECTION REPORT

555 Sample Address

Inspection Prepared For: Sample Commercial Inspection

Date of Inspection: 8/18/2018

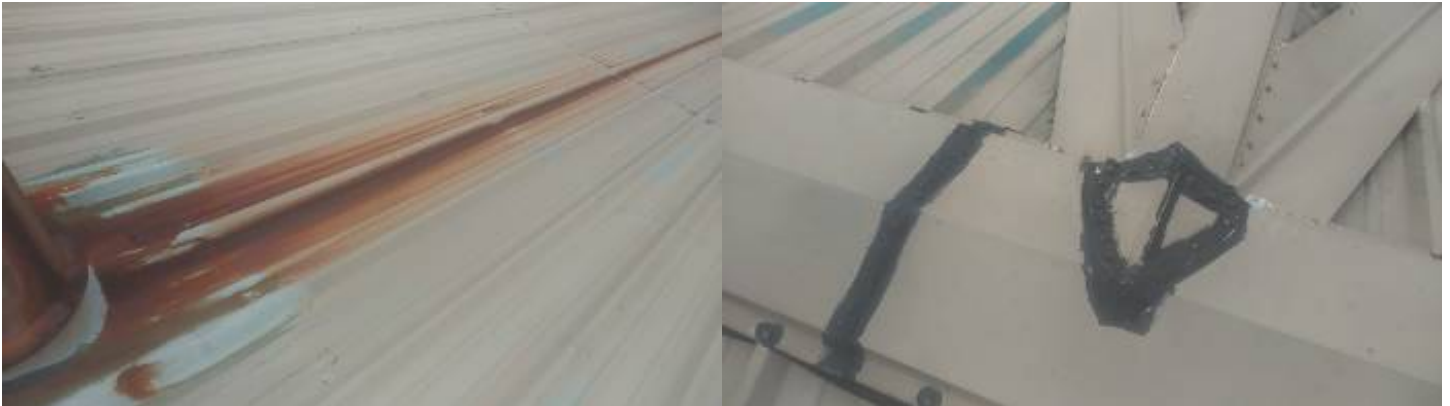
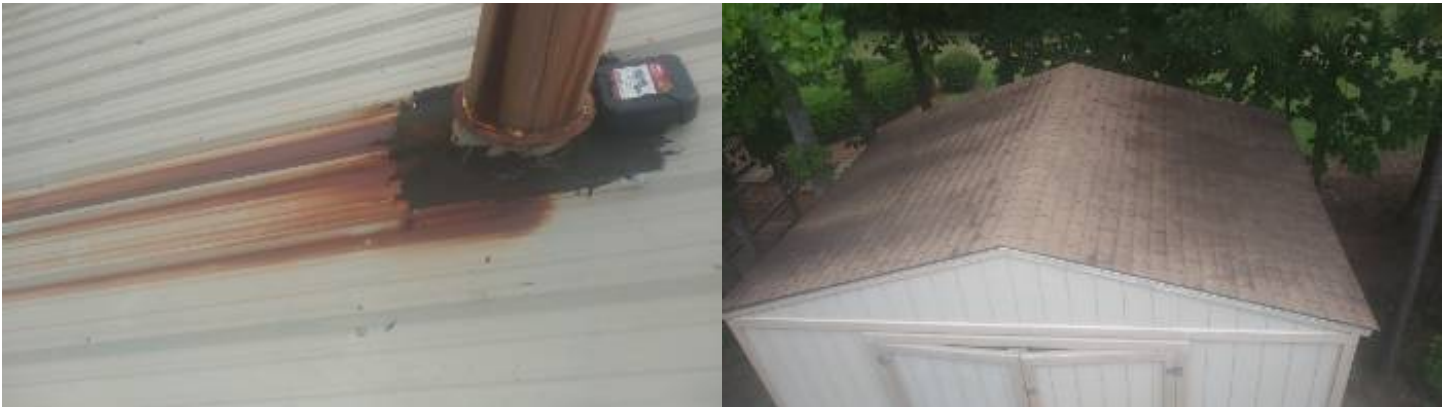
- there are coatings available for metal roofs. When the roof is no longer in good service instead of replacing the roof Coatings can be applied.
- the roof covering does appear to be in generally good condition but there are a few issues. There is rust building up below the vents. There are screws backing out and there are old repairs. Have a qualified contractor repair. Some of the metal that's heavily rusted may need replaced. Screws that are backing out need to be replaced by wider and longer screws. The repairs appear to have been done well but have gotten old and could use a little TLC.

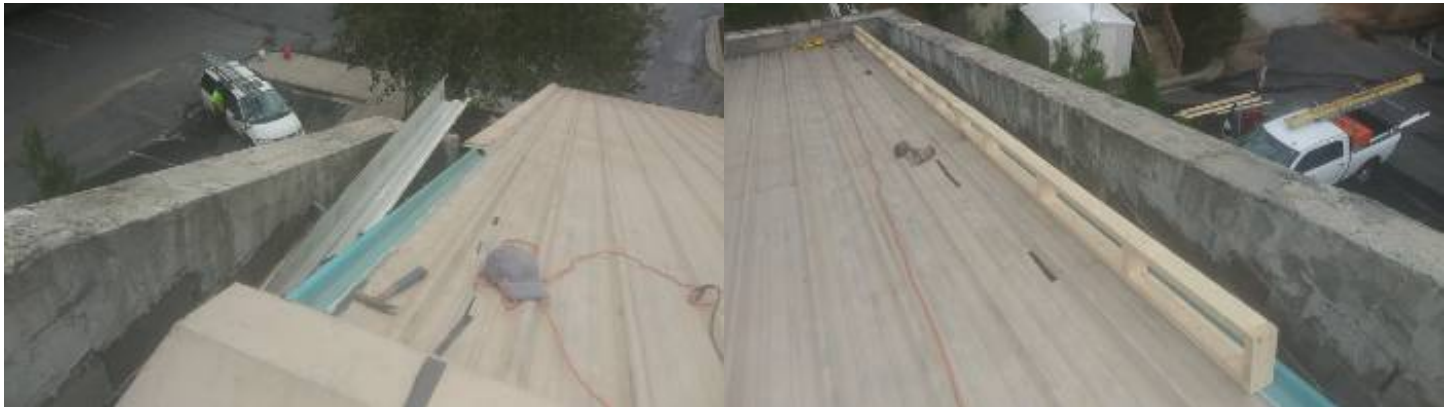
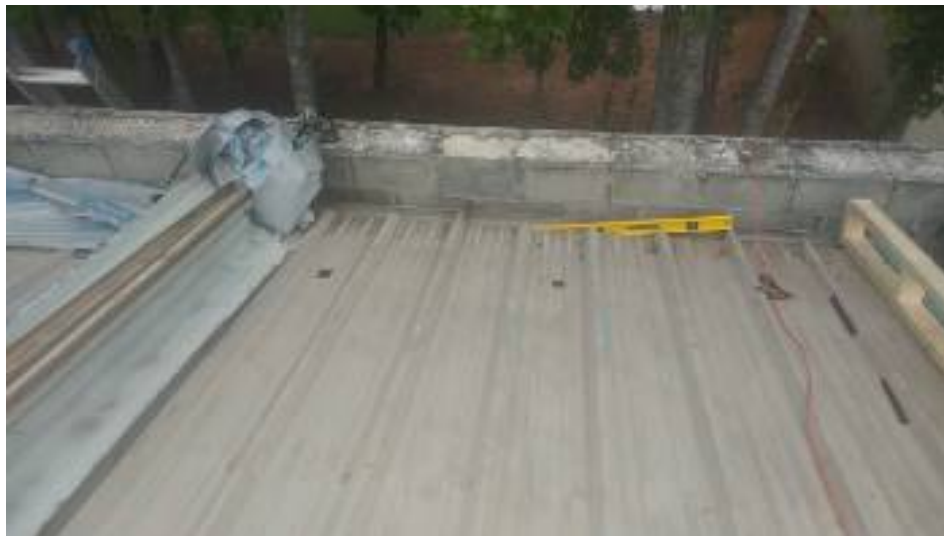
- the roof slope looks good but a repairs being made. The facilities manager told me this additional block wall was built to block sound from neighboring homes. There's an issue with where the water goes. A contractor is building a wall that he says will be wrapped with metal. If done properly this will probably fix the issue at the end of the Gable. At the bottom of the roof in the back it probably will not. If Rafters were built and decked with plywood and then metal roof installed above this may work. It would allow the water to go over the wall and not behind the wall. Have a qualified contractor evaluate repair or replace as necessary

Needs a sloped roof going over the wall

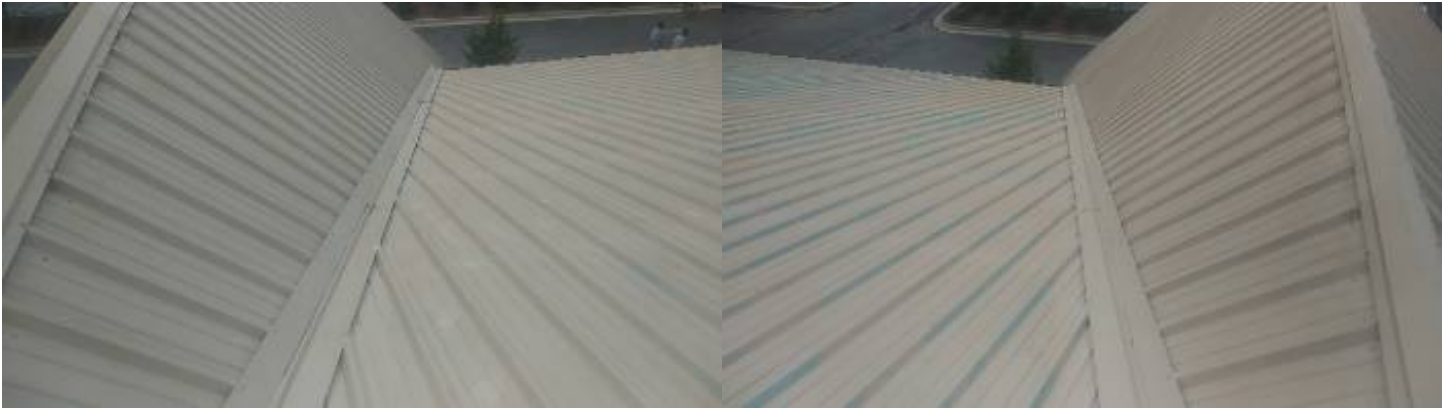
- there is a flashing covering the **valley flashing**. This is not a standard application and the valley flashing is very hard to inspect. I will inspect inside for signs of water entry.

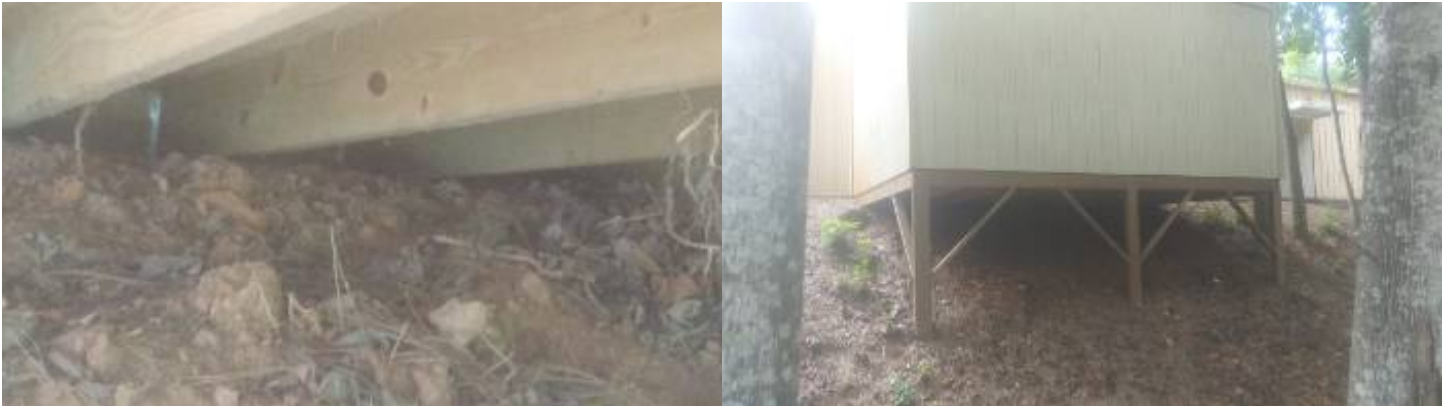
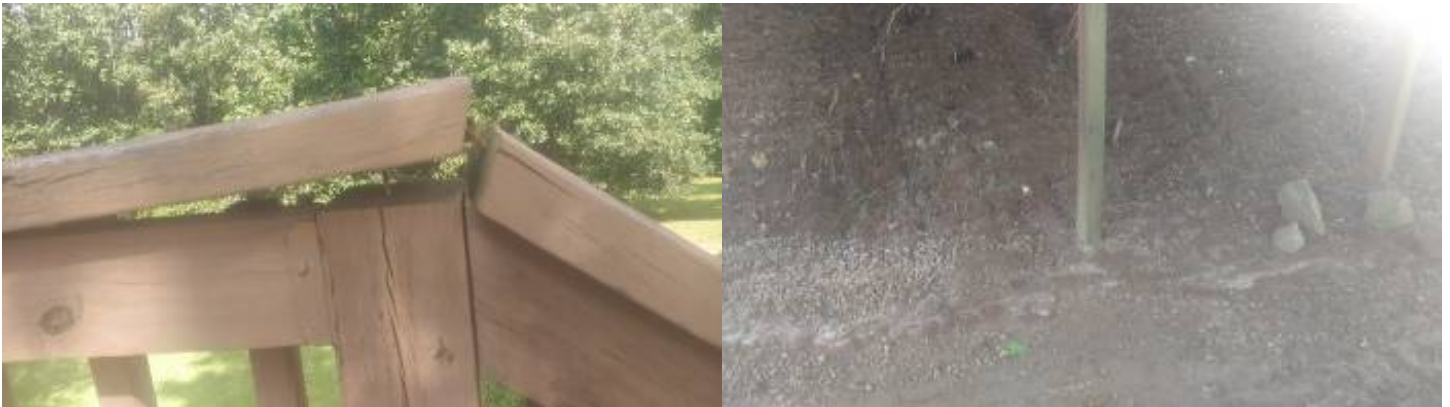
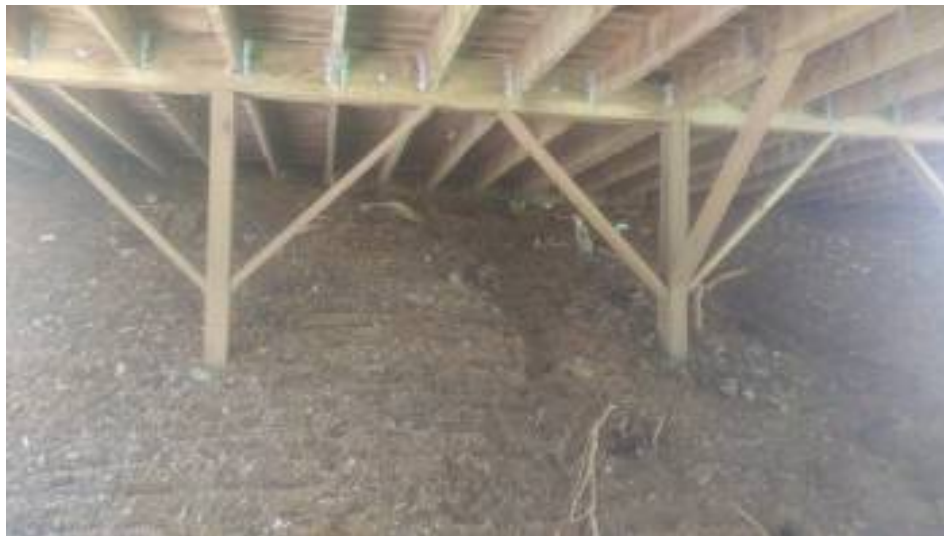
- some of the handrails appear to be deteriorating have a qualified contractor repair or replace
- some of the handrails on the back deck have deteriorated have a qualified contractor repair
- Wood will rot more quickly when there is wood to ground contact. All wood should be supported by a concrete foundation with a fastener attachment. It is good to have at least six inches of concrete visible. Wood to ground contact is also a entry point for insects and moisture. Keep up a termite letter and treatment on this building.

The large wood deck has a lot of wood to ground contact

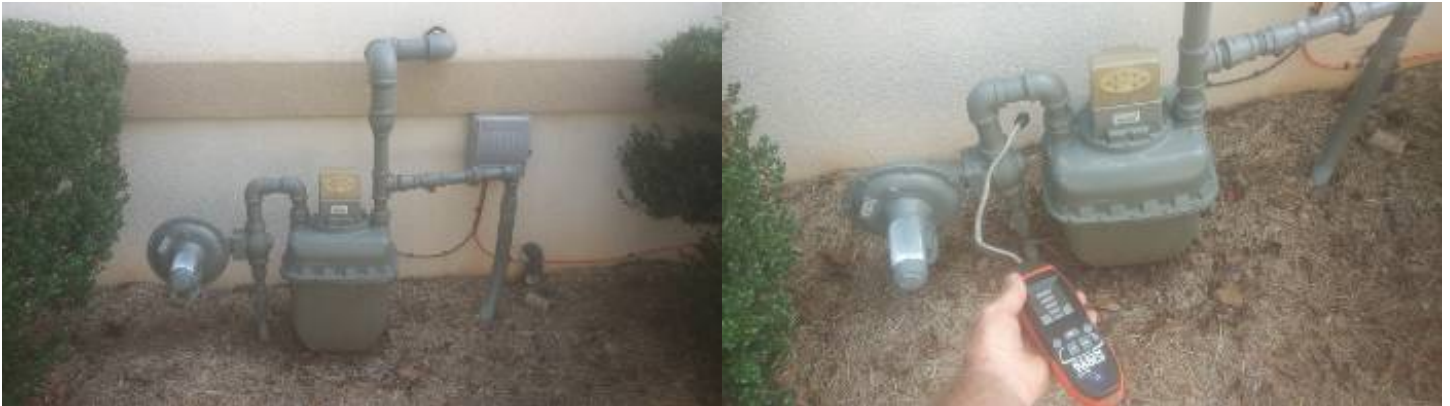
Observations: The Meter was inspected and tested for leaks. No leaks were found and the meter appears to be in serviceable condition.

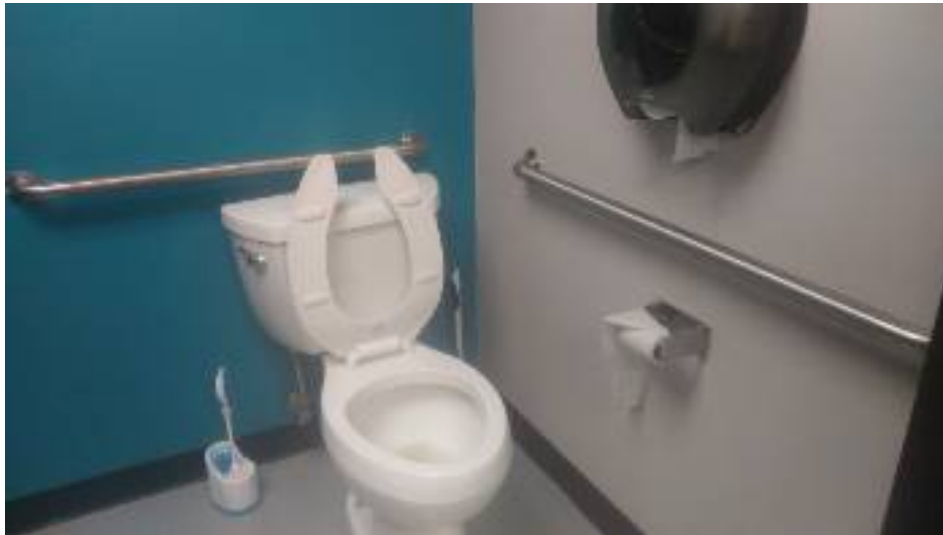
- grab bars in the men's bathroom are a little loose have a qualified contractor repair

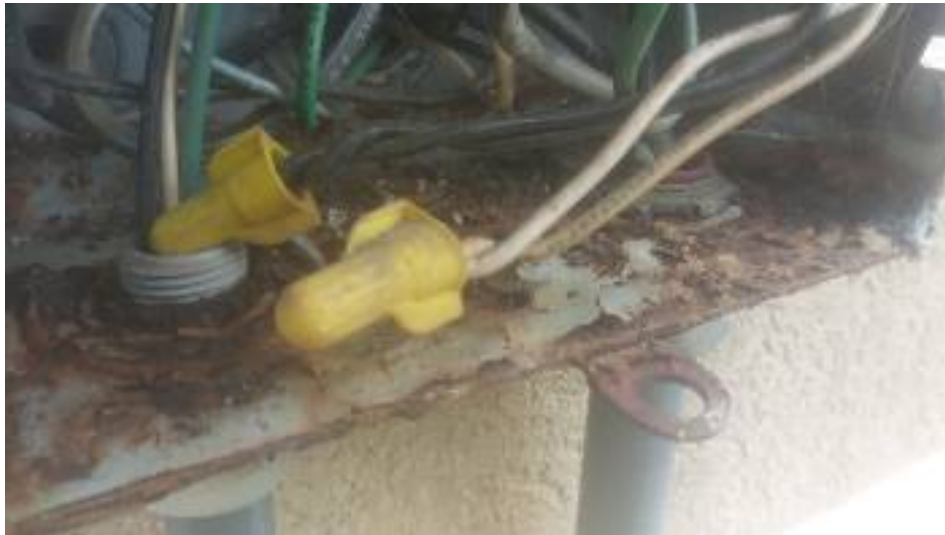
- The electrical service disconnect for the air conditioning condenser was damaged at panel housing. A qualified contractor should evaluate and repair/replace as necessary.

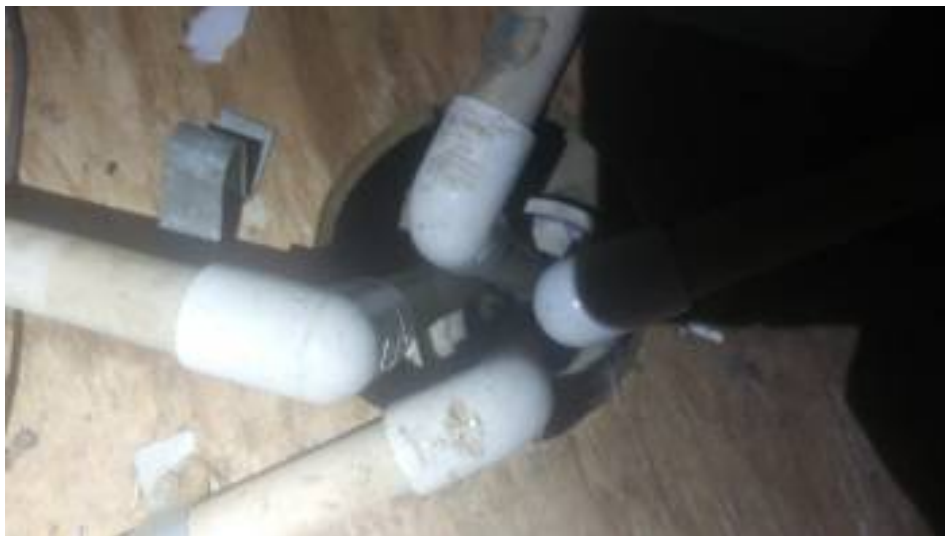
- all 4 conditioners on the left side dispense into a drain that appears to be full have a qualified contractor repair

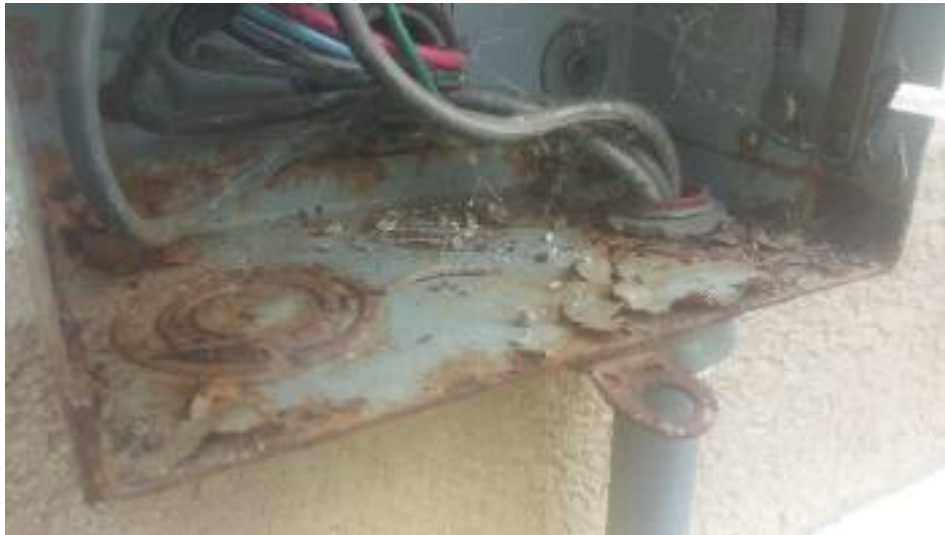
- The electrical service disconnect for the air conditioning condenser was damaged at panel housing. A qualified contractor should evaluate and repair/replace as necessary.

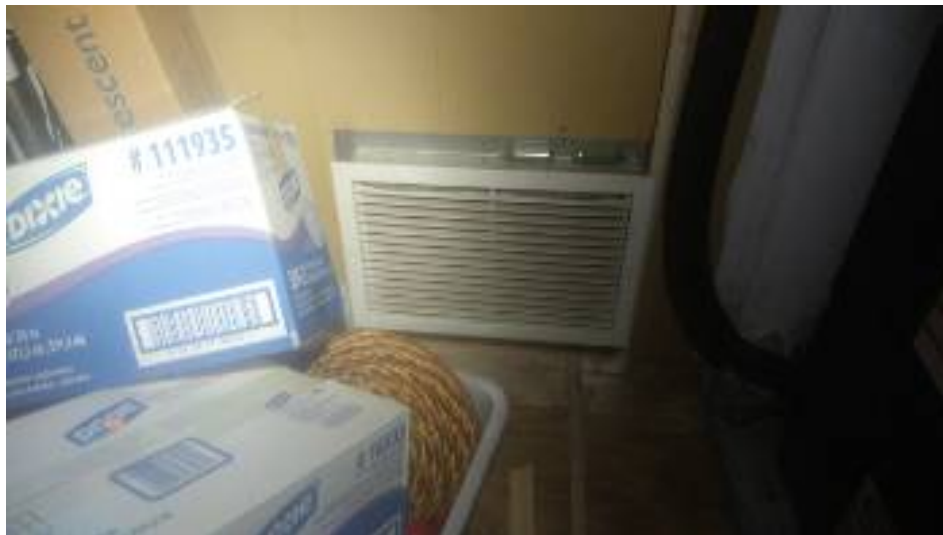
- it appears the bent in the photo Maybe the combustion air. I didn't see it blocked by items in the Attic. This space should not be for storage have a qualified HVAC contractor be certain there is combustion Air Supply
- The combustion air supply for this appliance was not present. A qualified contractor should evaluate and make necessary corrections according to current standards. Combustion air provides the oxygen needed for the safe and efficient operation of fuel burning appliances. An adequate supply of fresh air around all fuel burning appliances with open combustion compartments is vital for their safe operation. Years ago, the air could come from inside or outside the building, however, more recent standards prefer for combustion air to come from the outside only.
