PROPERTY INSPECTION REPORT

555 Sample Address

Inspection Prepared For: Sample Commercial Inspection

Date of Inspection: 8/18/2018

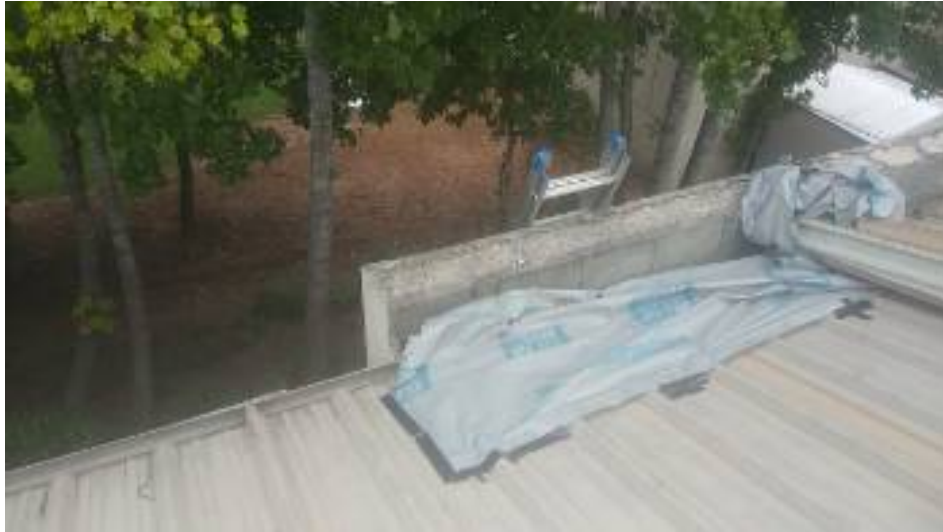
- there is no permanent roof access but you can access the roof in less than 16 feet of height.

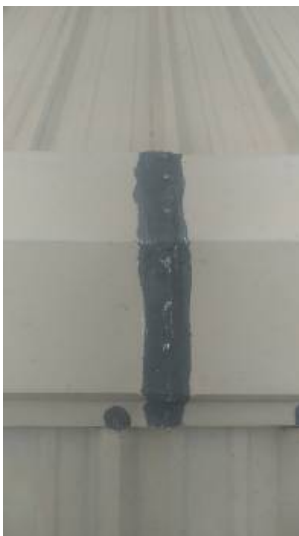
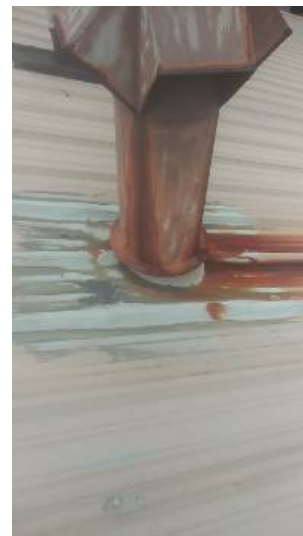
- there are coatings available for metal roofs. When the roof is no longer in good service instead of replacing the roof Coatings can be applied.
- the roof covering does appear to be in generally good condition but there are a few issues. There is rust building up below the vents. There are screws backing out and there are old repairs. Have a qualified contractor repair. Some of the metal that's heavily rusted may need replaced. Screws that are backing out need to be replaced by wider and longer screws. The repairs appear to have been done well but have gotten old and could use a little TLC.

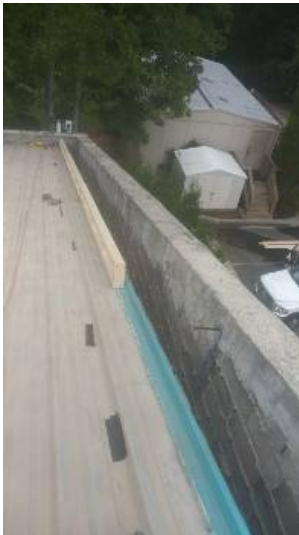
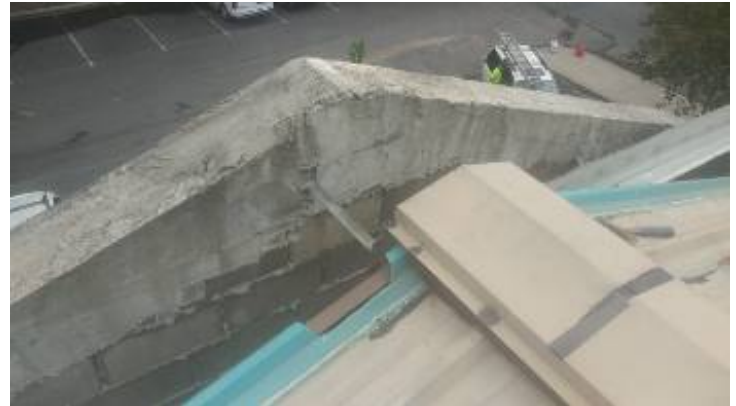
- the roof slope looks good but a repairs being made. The facilities manager told me this additional block wall was built to block sound from neighboring homes. There's an issue with where the water goes. A contractor is building a wall that he says will be wrapped with metal. If done properly this will probably fix the issue at the end of the Gable. At the bottom of the roof in the back it probably will not. If Rafters were built and decked with plywood and then metal roof installed above this may work. It would allow the water to go over the wall and not behind the wall. Have a qualified contractor evaluate repair or replace as necessary

Needs a sloped roof going over the wall

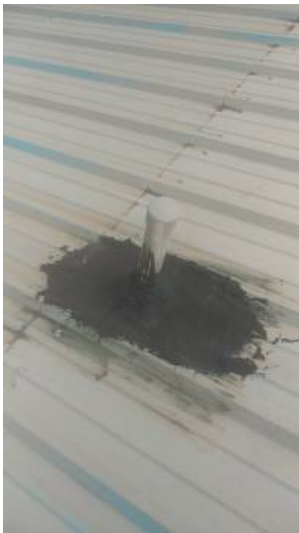
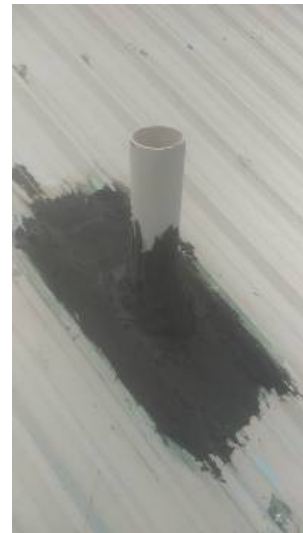
- 1 Plumbing vent is capped and no longer in service. If this van is not needed it would be better to remove it entirely and lay a new piece of metal. I will check inside for drainage issues. There's only one other plumbing vent and it appears to have been repaired several times. I will look for leaks but this has obviously been problematic.

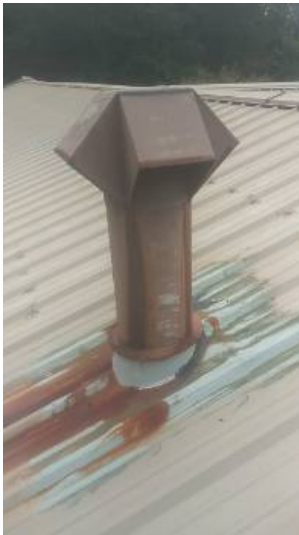
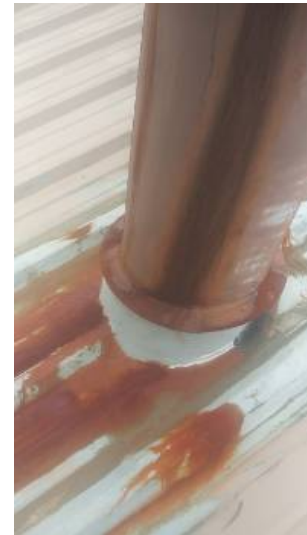
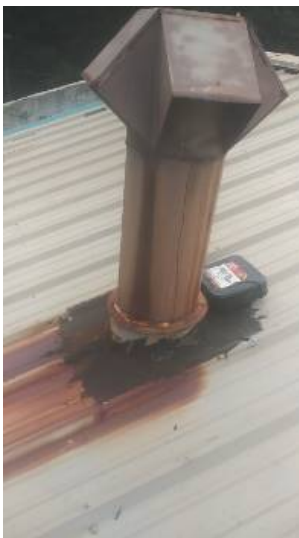
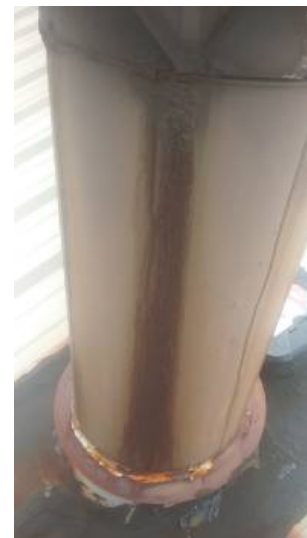
- One or more combustion appliance exhaust flue(s) exhibited corrosion. A qualified contractor should evaluate and repair/replace as necessary.

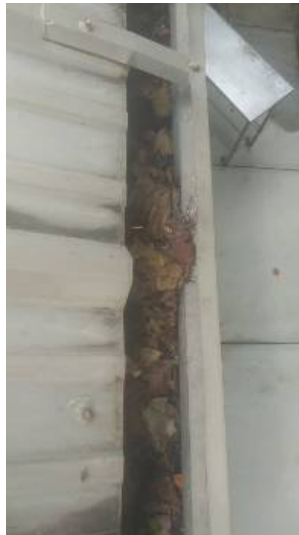
- Gutters were full of debris in areas and need to be cleaned. The debris in gutters can also conceal rust, deterioration or leaks that are not visible until cleaned. This condition may cause problems by introducing excessive amounts of moisture to the soil beneath the foundation. Excessive moisture in soil supporting the foundation can affect its ability to support the weight of the structure above and may cause foundation damage from soil movement. A qualified contractor should evaluate and repair or replace as necessary and according to current standards.

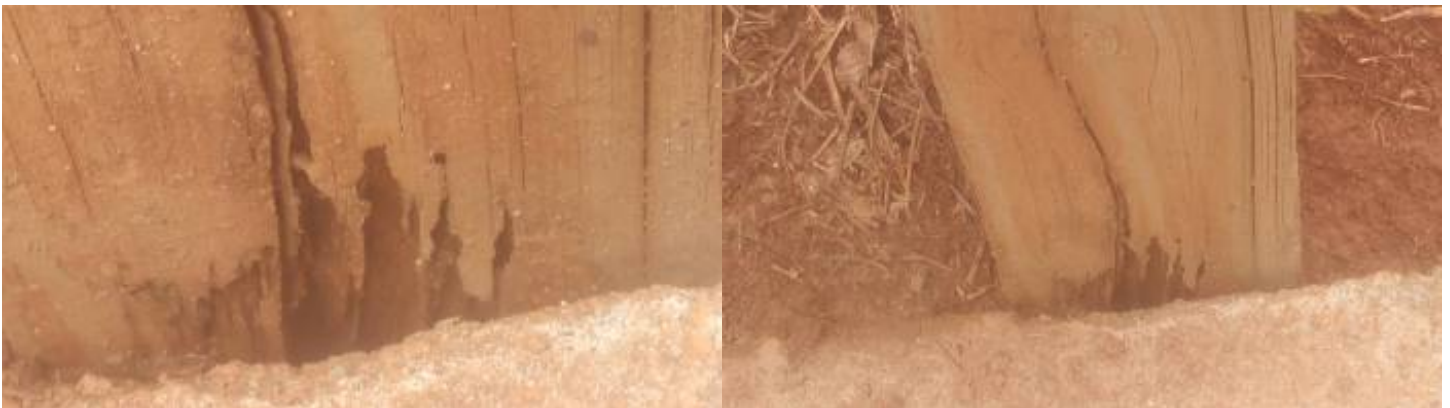
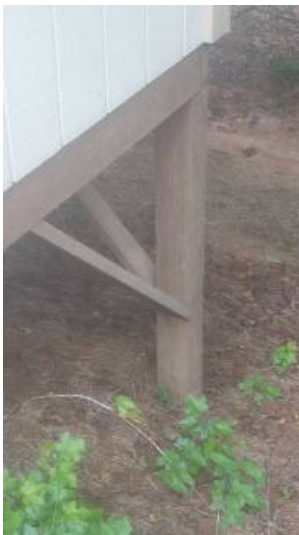
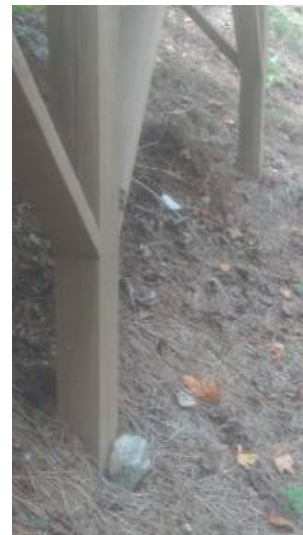
- some of the handrails appear to be deteriorating have a qualified contractor repair or replace
- some of the handrails on the back deck have deteriorated have a qualified contractor repair
- Wood will rot more quickly when there is wood to ground contact. All wood should be supported by a concrete foundation with a fastener attachment. It is good to have at least six inches of concrete visible. Wood to ground contact is also a entry point for insects and moisture. Keep up a termite letter and treatment on this building.

The large wood deck has a lot of wood to ground contact

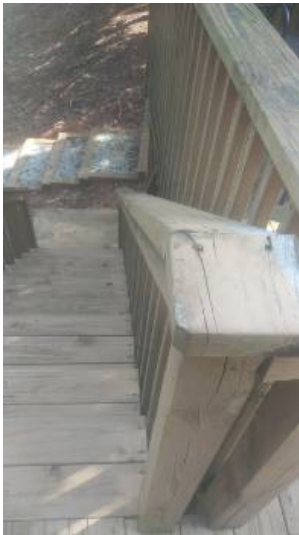
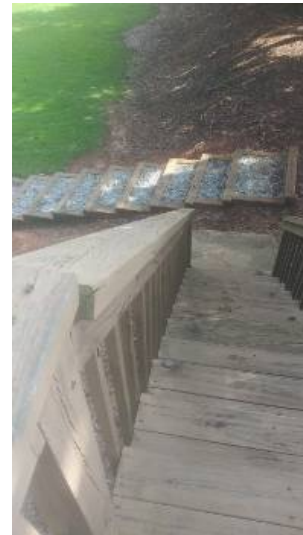
Observations: **The handrail was Non Graspable, this is a safety concern. Have a qualified contractor evaluate, repair or replace as necessary.**

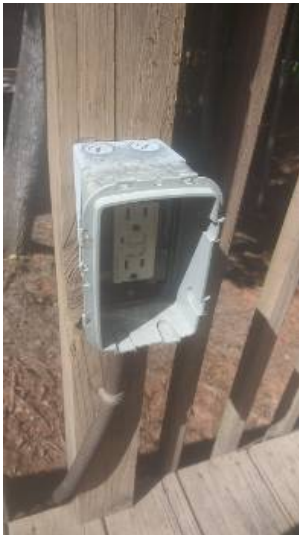
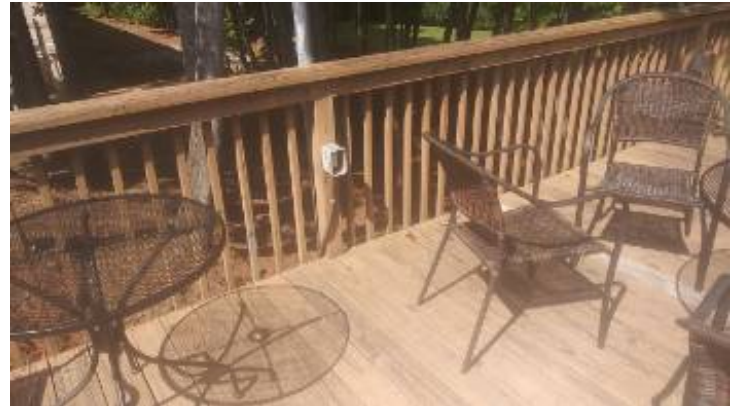
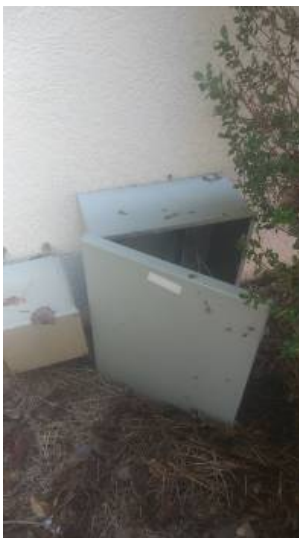
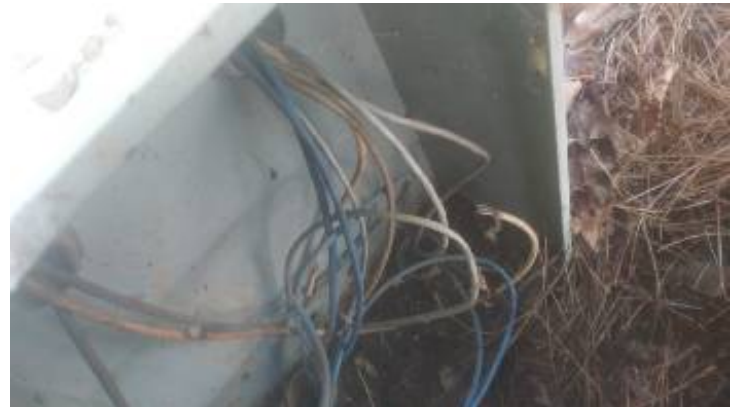
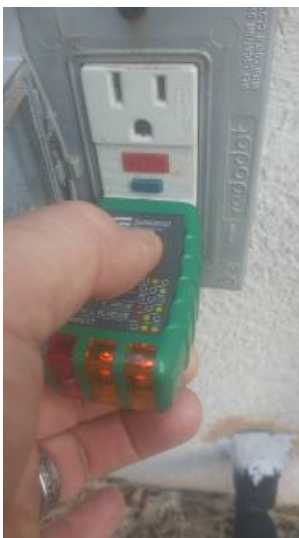
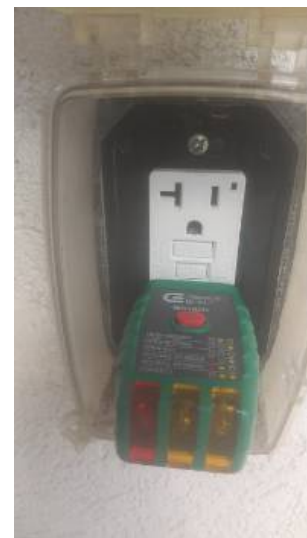
Observations: back left corner of the building has an electrical box down in grade it would be a good idea to prepare this or remove it. It does not appear to have a use at this time, front **GFCI** is not resetting have a qualified contractor repair, No ground fault circuit interrupter (GFCI) protection was provided for the exterior electrical outlets. A qualified contractor should evaluate and repair or replace as necessary. , The electrical outlet is missing the waterproof cover . A qualified contractor should evaluate and repair or replace as necessary.

Did not trip when tested

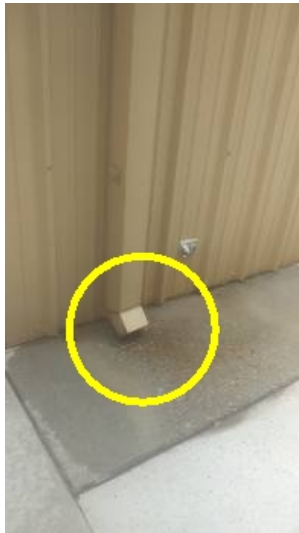
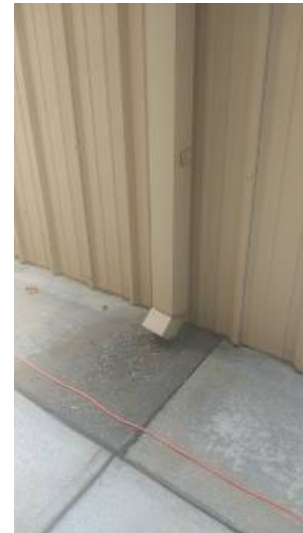
- some of the gutters appear to need resealing have a qualified contractor repair
- Downspout(s) need to have extensions reconnected. This condition may cause problems by introducing excessive amounts of moisture to the soil beneath the foundation. Excessive moisture in soil supporting the foundation can affect its ability to support the weight of the structure above and may cause foundation damage from soil movement. When moisture is introduced to the foundation it could also cause possible mold growth. A qualified contractor should evaluate and repair or replace as necessary and according to current standards.

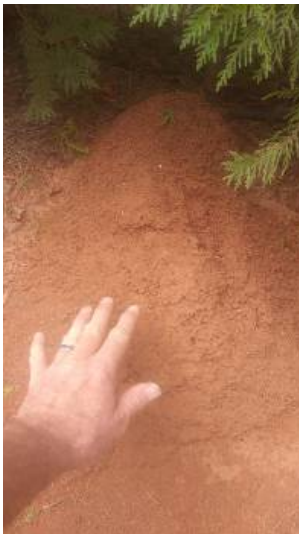
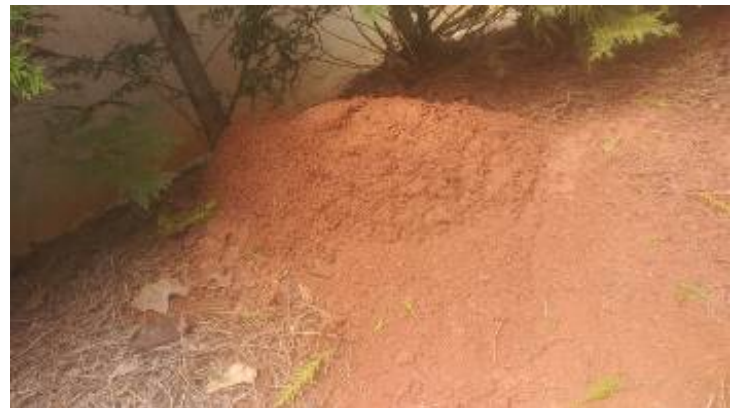
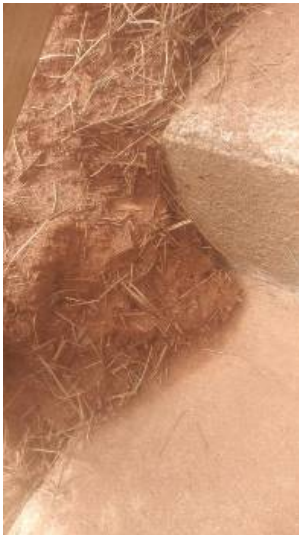
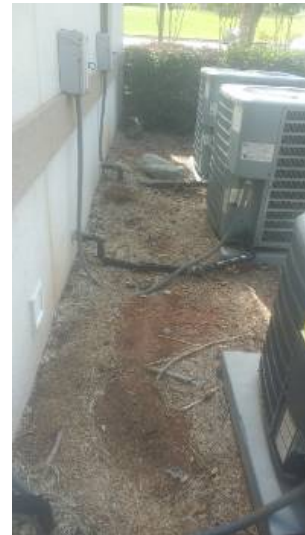
Observations: there are signs of a lot of ants and insects. Also the wall surface goes below grade. Have a qualified contractor spray for bugs and termites also keep up a termite letter., on the left side of the property the drainage is negative or level at the heating and air systems. This could cause moisture issues inside.

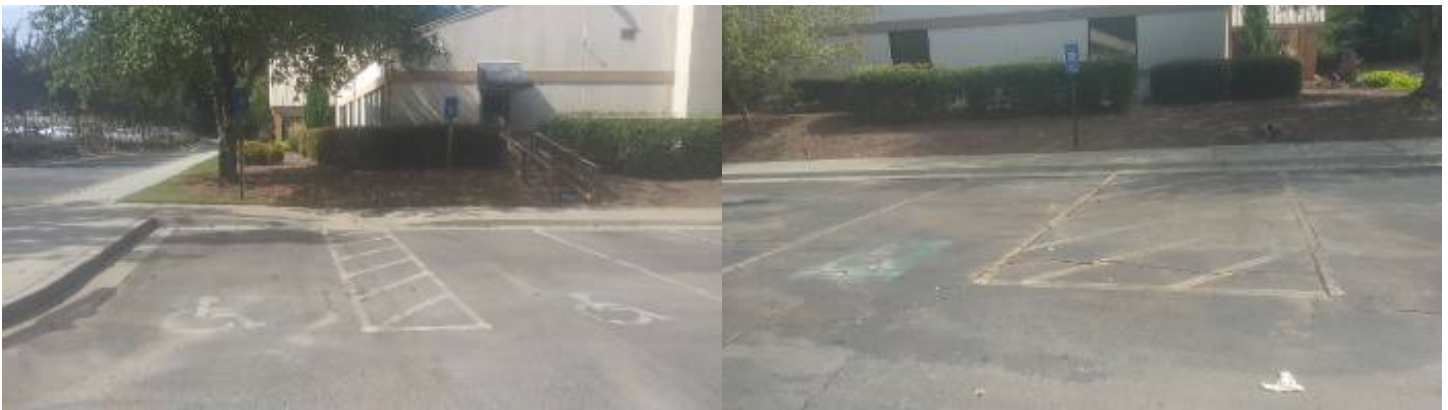
- there is Ada parking available. The only man parking is only available for the other building to the left. There is no ramp access on the sidewalk for the main building. Have a qualified contractor install.

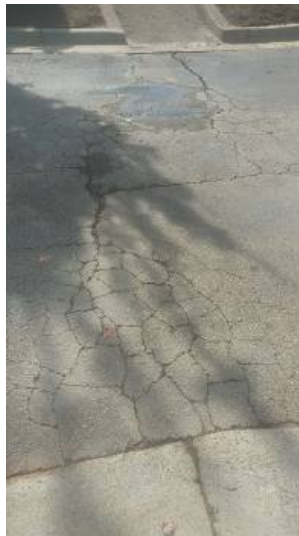
- roads have some major cracking in areas minor and others repairs will be needed soon. The longer they wait the worse they will get, most of the damage happens in the winter when ice freezes.

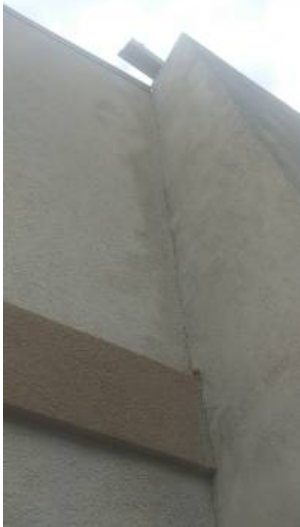
- water can Infiltrate The building at the back walkway. The metal is rusting at concrete height. This area should be sealed. Have a qualified contractor repair.

- Exterior walls of the property appeared to be covered with a synthetic stucco product called Exterior Insulation and Finish Systems (EIFS). EIFS has installation requirements, different from hard coat stucco, which have been widely misunderstood. Many structures with EIFS exterior wall coverings have had EIFS applied by installers who were not qualified, and defective installations are common. Many EIFS-clad buildings have revealed moisture-related problems, such as deteriorated wood framing and pest infestation. Testing of this cladding requires a specialty inspection and is beyond the scope of this inspection. A qualified contractor should evaluate and repair or replace as necessary and according to current standards. The EIFS product has been run into the ground and this is improper. It must be 6 in short of grade.

Signs of possible high moisture content

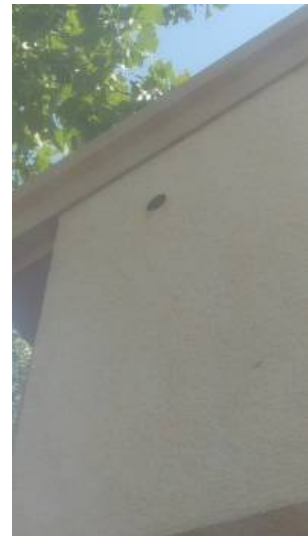
Whole should be repaired in back left corner

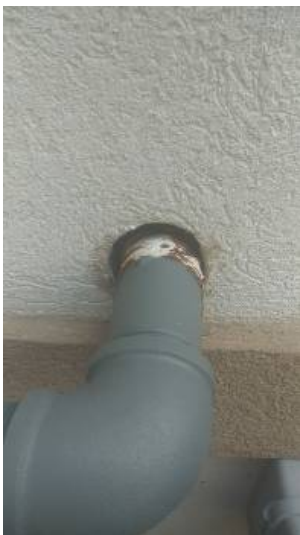
The opening around the gas meter piping should be sealed up.

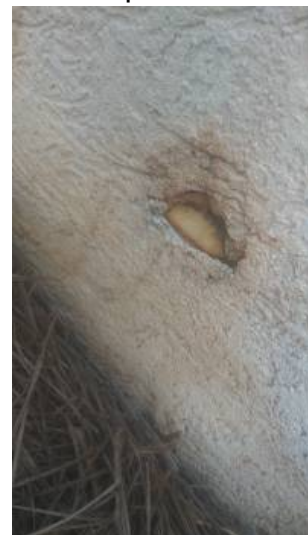
This is a sign that it does run underground have a qualified contractor repair

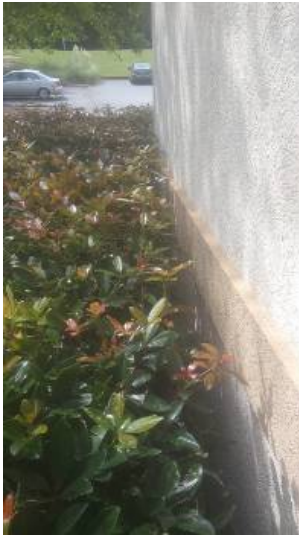
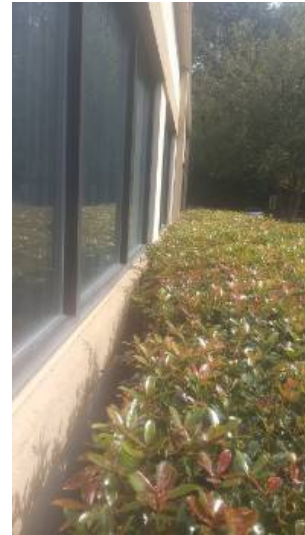
- Vegetation is in contact with the building. This can be an entry point for insects and or moisture. Keep up a termite treatment and letter on this property. Have a qualified contractor evaluate and repair the situation.

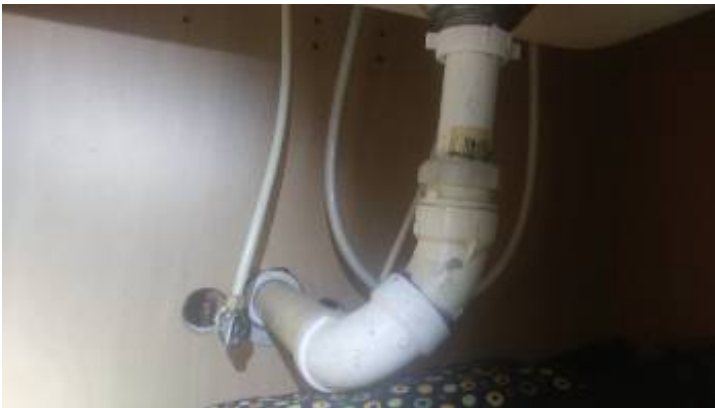
- The sink in the coffee room doesn't appear to ever get hot water have a qualified contractor repair
- childcare room sink is operational. No leaks found and did have hot water
- the drain in the second child care room has no P-trap have a qualified contractor repair. Also drains slowly

No P-trap

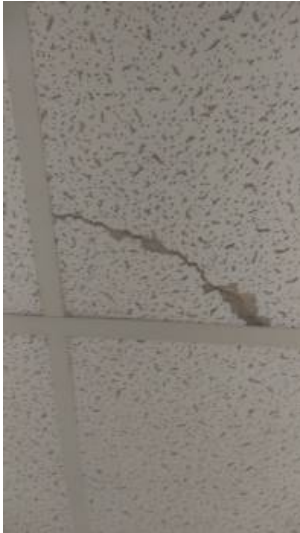
Various broken ceiling tiles

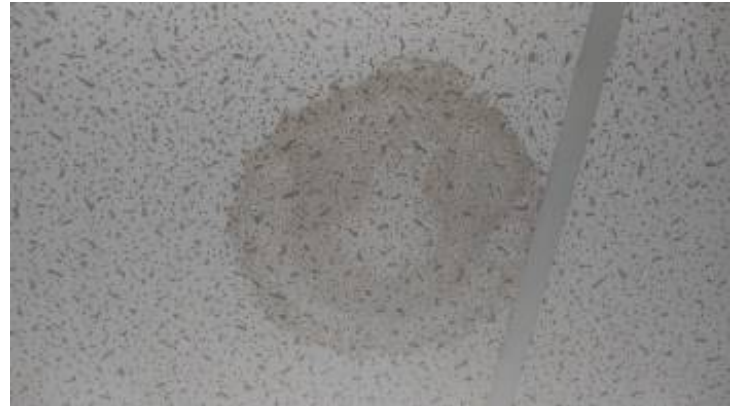
Very stained ceiling tiles I will note if they're still moisture.

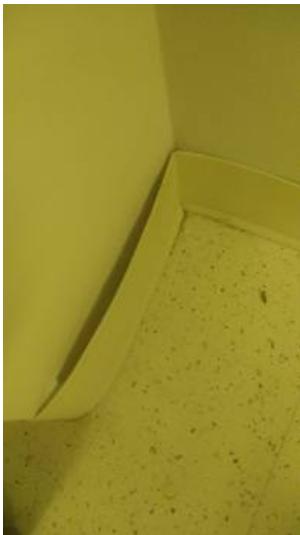
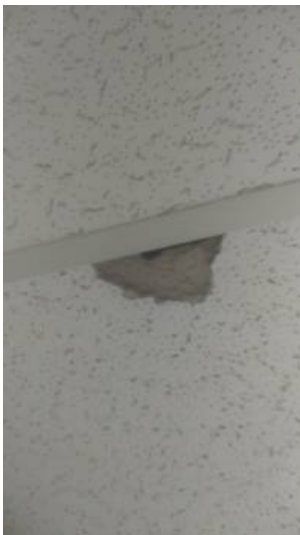
Several defects on ceiling tiles

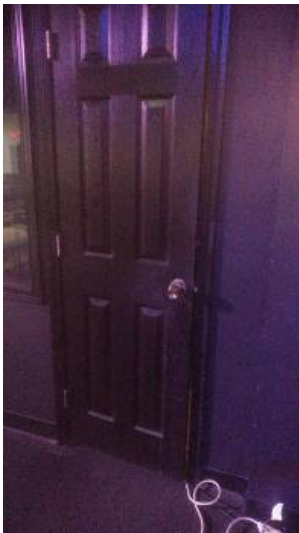
- the seal is broken on the exterior door on the far right side have a qualified contractor repair
- The door rubbed the doorjamb when closing. A qualified contractor should evaluate and repair or replace as necessary.

Door on stage rubs jam

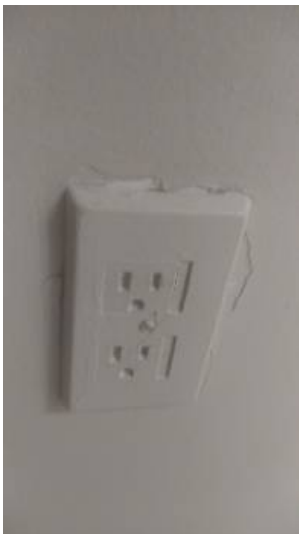
Childcare room

- Outlet in childcare room painted shut have a qualified contractor repair
- Outlet not child safe in childcare room have a qualified contractor repair
- Mini receptacles are not tamper proof have a qualified contractor repair
- An electrical outlet was loose in the wall. A qualified contractor should evaluate and repair or replace as necessary.
- A GFCI outlet was defective and will not reset once tripped. A qualified contractor should evaluate and repair or replace as necessary.

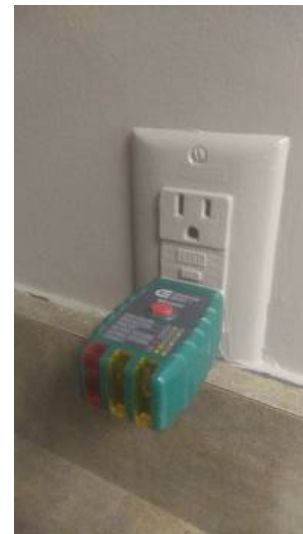
Outlet will not reset in childcare room

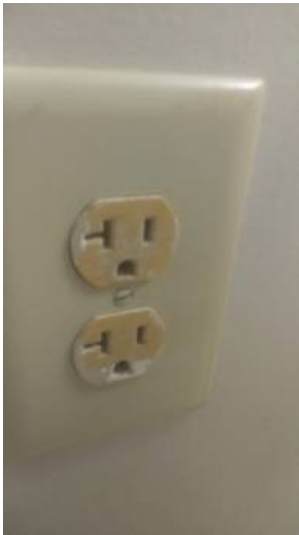
Childcare room not child safe

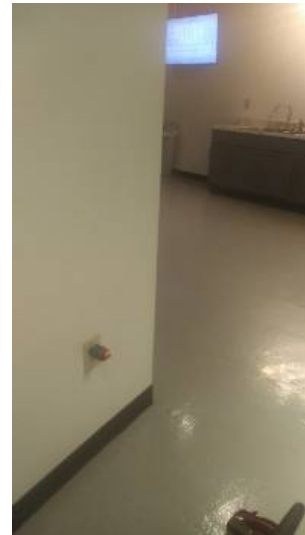
Outlet loose left side of the building

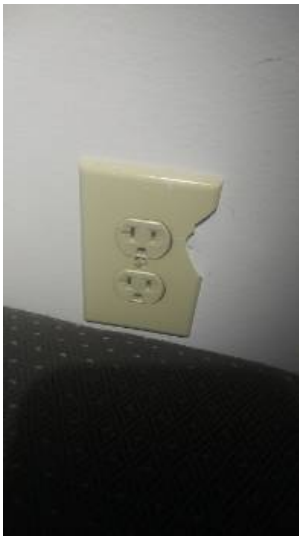
Not tamper proof and broken cover

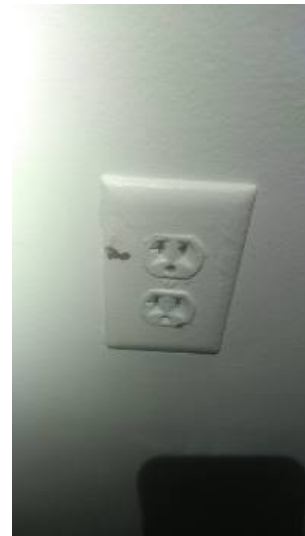
Painted receptacle in sanctuary not usable

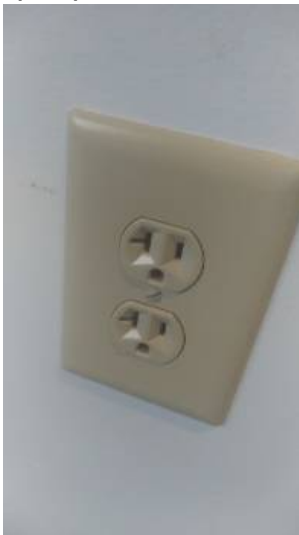
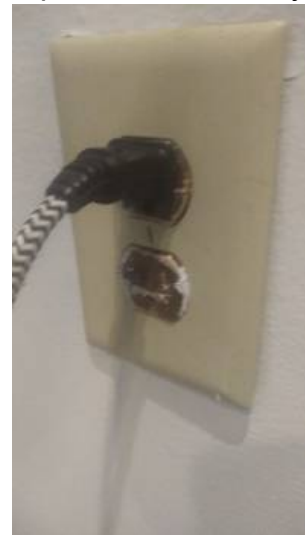
Mini plugs are painted shut but they need to be replaced for tamper-proof plugs.

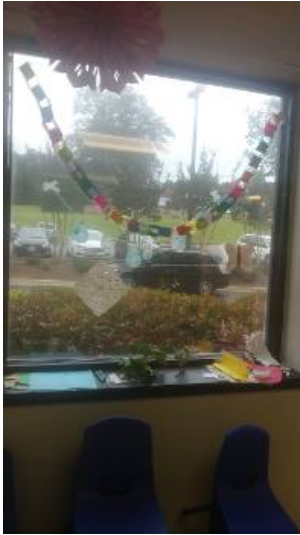
Childcare room left side

- there's a broken window in the room where they prepared to go on stage have a qualified contractor replace
- several of the windows have broken their Seal have a qualified contractor replace
- The seal appears to be blown in the coffee shop window have a qualified contractor replace
- The window appeared to have a broken seal that has been compromised. Condensation and/or cloudiness between the two panes of glass was observed. This will have a negative impact on energy efficiency. Also, because there is moisture between the panes with no ventilation, mold can eventually develop. A qualified contractor should evaluate and repair or replace as necessary.

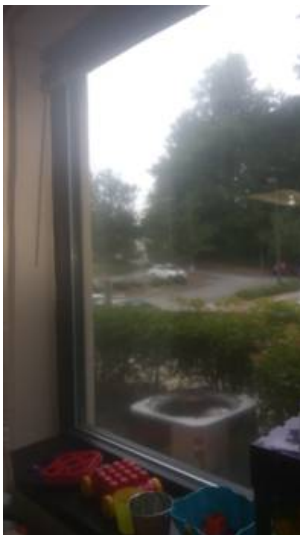
Broken seal in second child care room

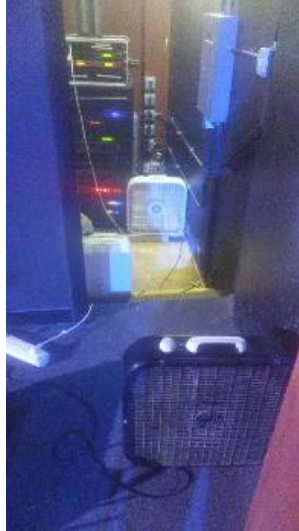
- there is a roofer making roofing repairs on the far right-hand side of the building. At this time in the inside just under that location the property manager has two fans and dehumidifier drying that area. This area will need to be checked after the roof repair is made.

Under roof repair

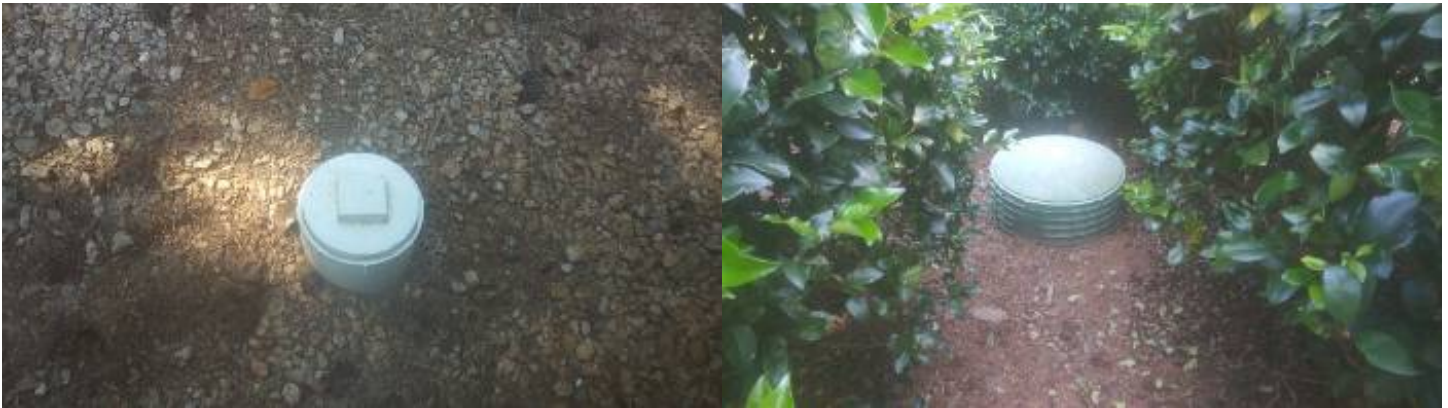
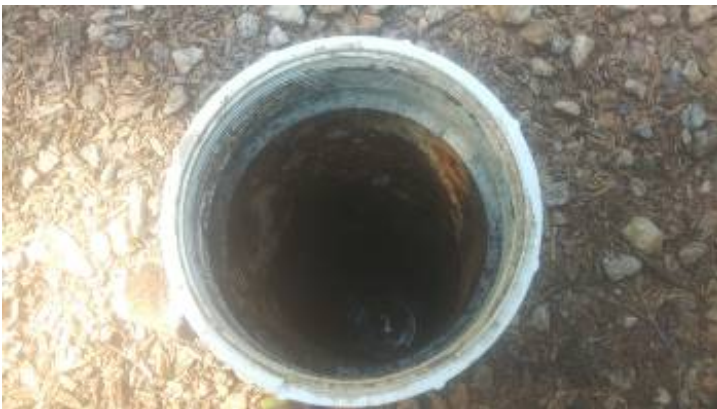
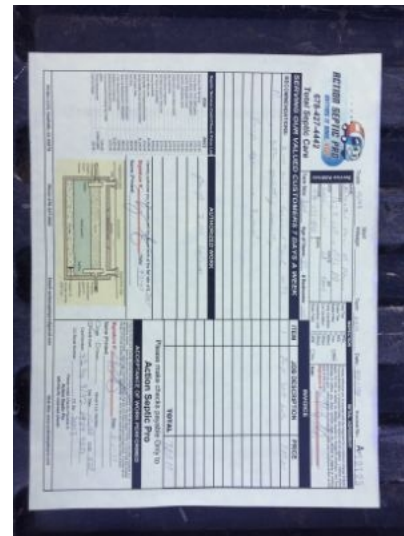
- the church has a receipt for having the septic tank pumped. I believe it was recently done. There's a clean out just in front of the tank, the sewage level is much higher than normal. It would be a good idea to ask the pumping company why. I would advise having a sewer scope test done. It could be very expensive if the sewage doesn't flow well.

Septic Pump Receipt, Cleanout looks Full ask company why

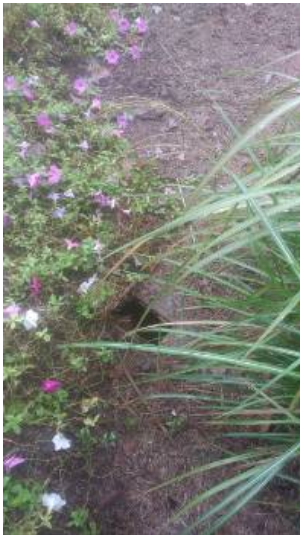
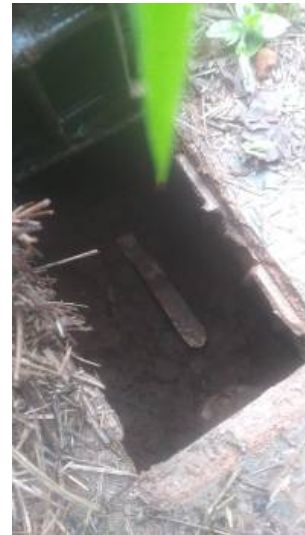
Materials: Main water shut-off is by the front door in the bed on the left side it is a little hard to access have a qualified contractor clean around the opening

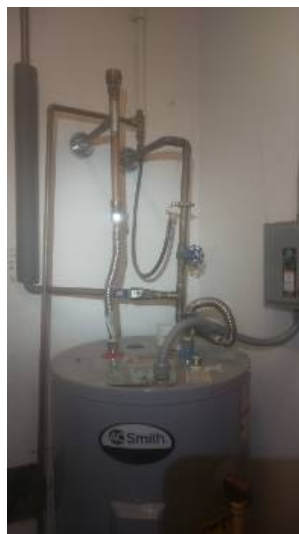
- The **expansion tank** was missing or not installed. A expansion tank relieves pressure and reduces banking pipes. Water does not expand and contract with pressure. A water tank reduces the stress on the lines. Have a qualified contractor install a expansion tank.

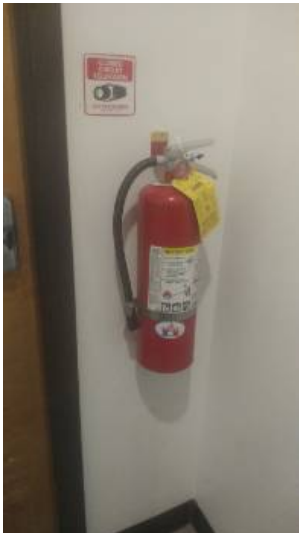
Buy childcare room

- There are fire extinguishers present and they are located in conspicuous accessible locations. They appear to be full and ready for use. Keep up a continued maintenance plan to inspect and test fire extinguishers.

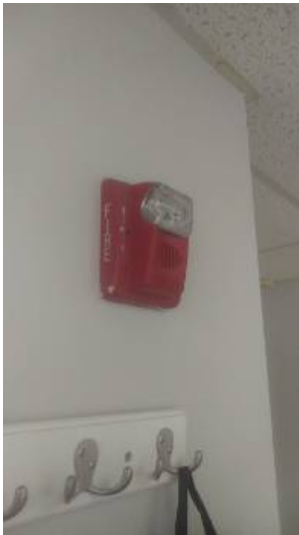
Childcare room

- We inspected for the presence and operation of the emergency lighting. The emergency lighting appears to be in acceptable condition. The fire marshal can order the change of emergency lighting if the fire marshal believes there is a hazardous situation.
- 1 exit light has a bad light at the front right side of the building

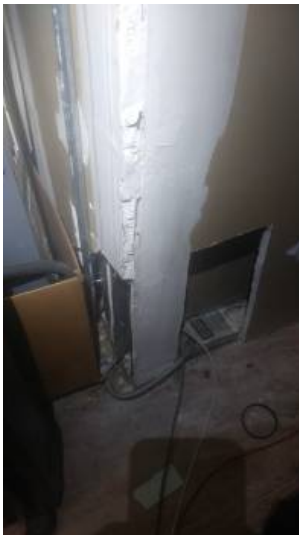
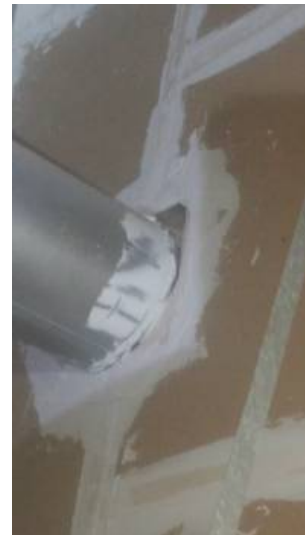
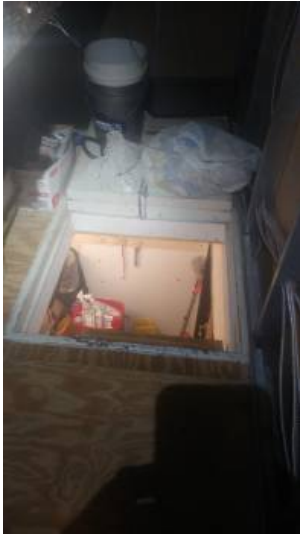
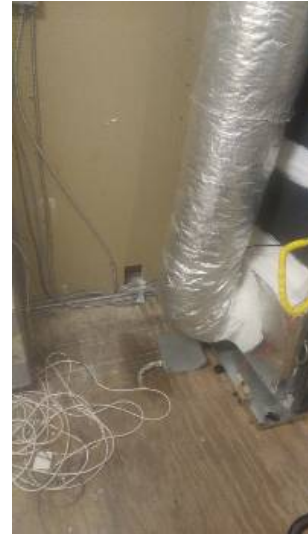
HVAC Attic by the stage

- it appears this attic hatch is part of the fireproof system but it is blocked open have a qualified contractor repair
- it appears that the outside of the Furnace room has a firewall and this wall has been penetrated have a qualified contractor repair

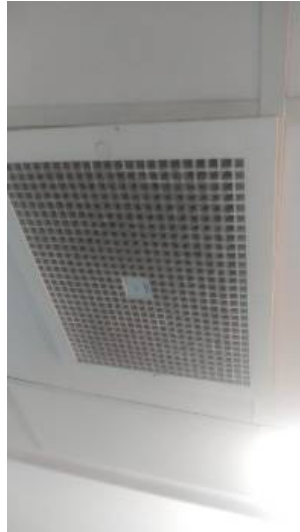
The fan is a little dirty have a qualified contractor repair

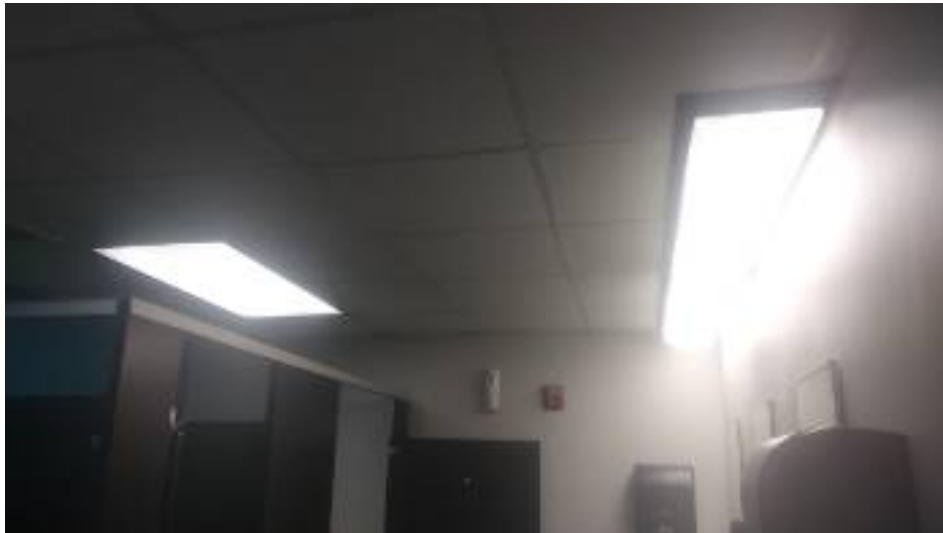
- broken cover plate and not tamper proof have a qualified contractor repair

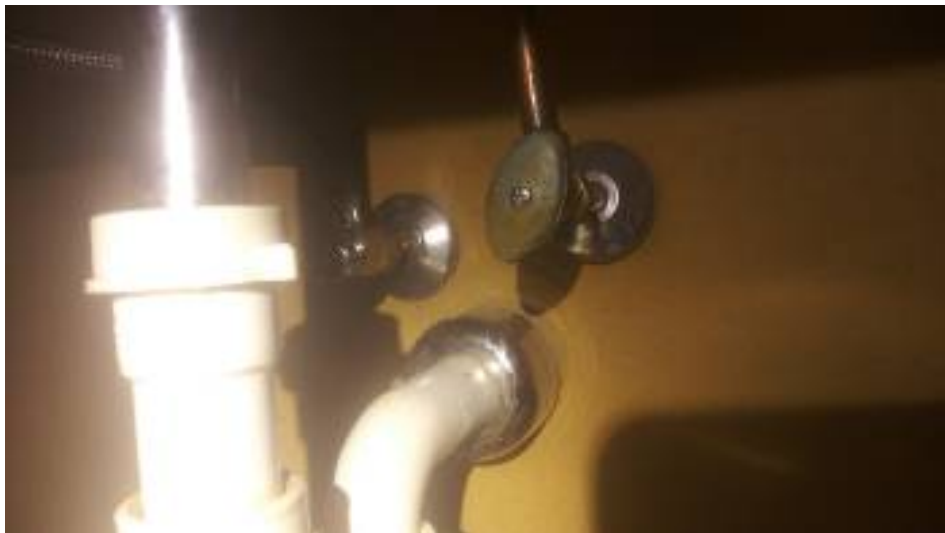
- the scald guard is not attached very well in the men's bathroom have a qualified contractor repair

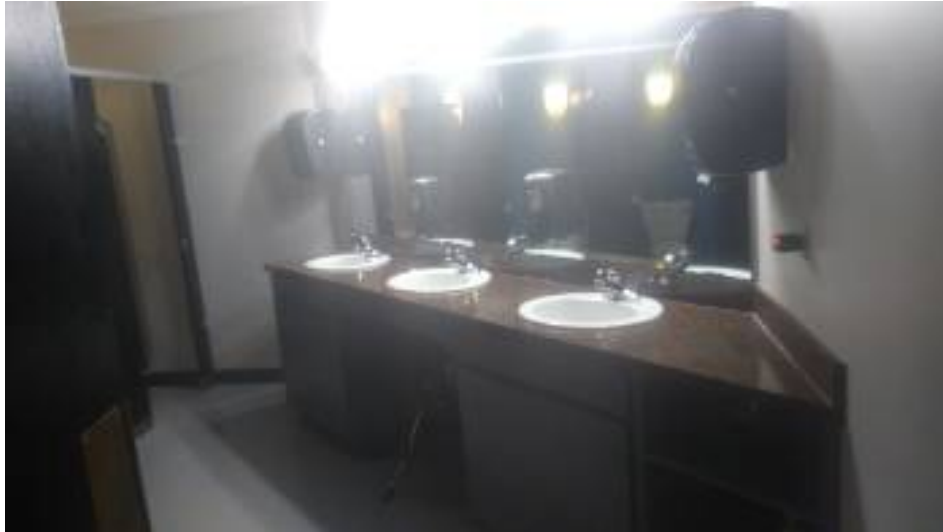
Bathroom Exhaust Fan

- There was no ventilation (exhaust fan or openable window) In the bathroom. Normally an exhaust fan or an openable window is needed for proper ventilation.

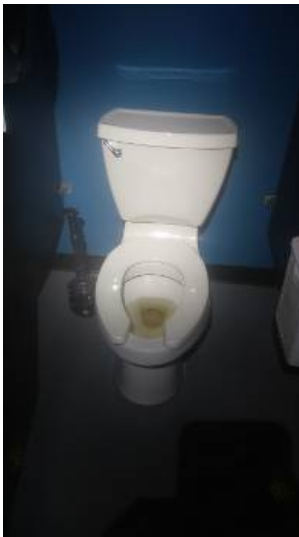
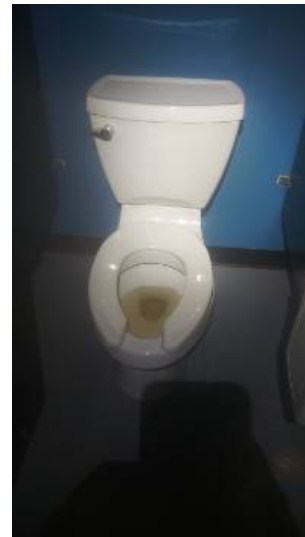
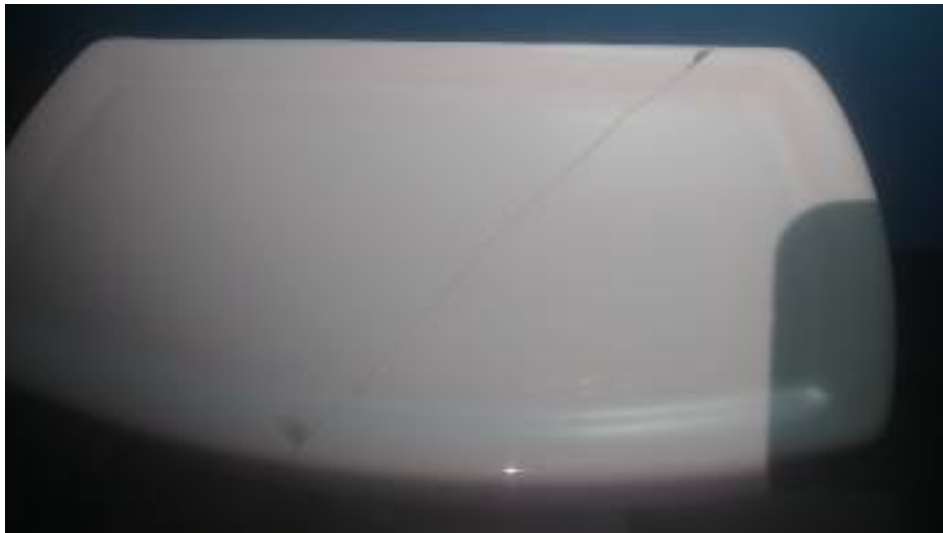
Toilets

- two toilets are running in the women's bathroom the second one from the left and the third one from the left have a qualified contractor repair
- second toilet from the left has a broken lid, furthest toilet to the right has a weak flush

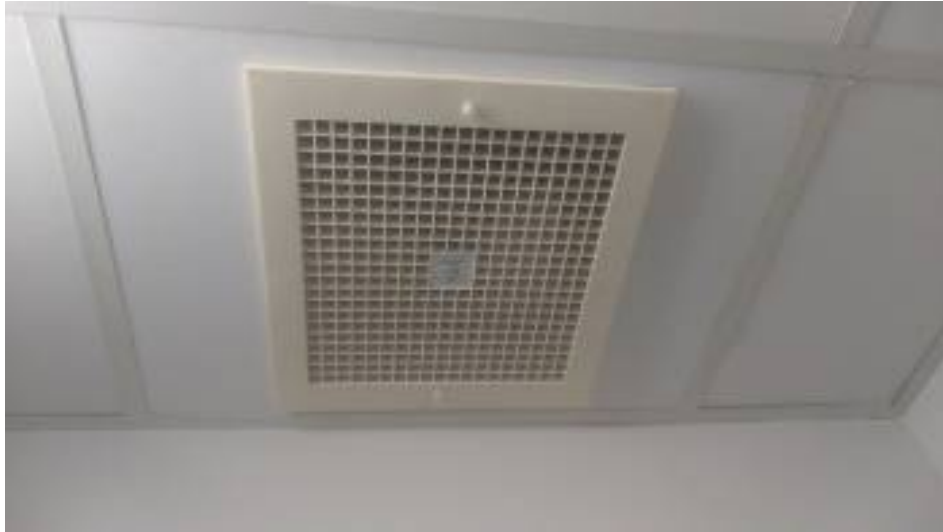
Bathroom Exhaust Fan

- The bathroom exhaust fan did not work. A qualified contractor should evaluate and repair or replace as necessary.

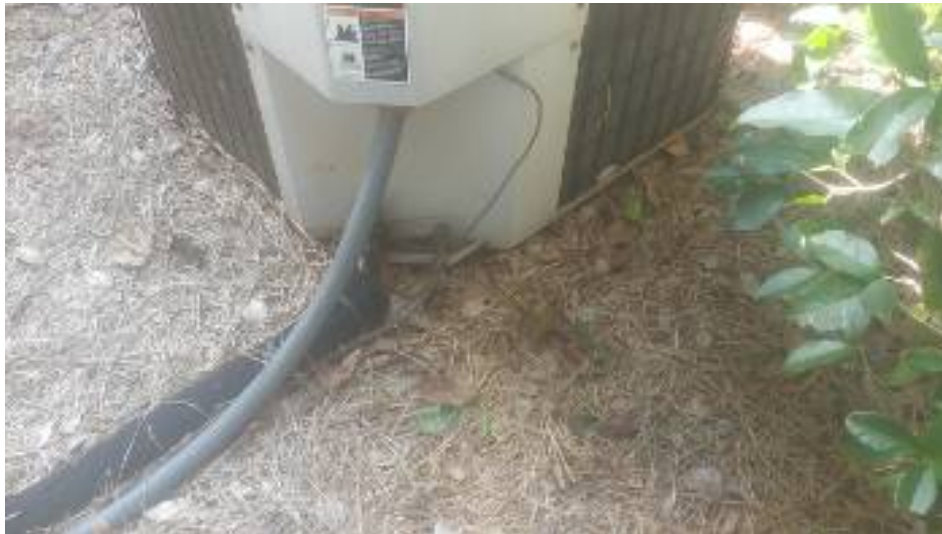
AC Compressor

- The air-conditioner compressor exterior cabinet appeared to be in serviceable condition at the time of the inspection.
- **keep the pine straw and any grade out of the bottom of the cabinet. And every HVAC system on the property**

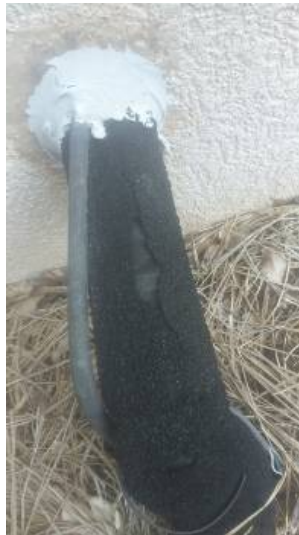
AC Refrigerant Lines

- **The air-conditioner refrigerant suction line (large, insulated) has damaged or missing insulation in areas. A qualified contractor should evaluate and repair/replace as necessary.**

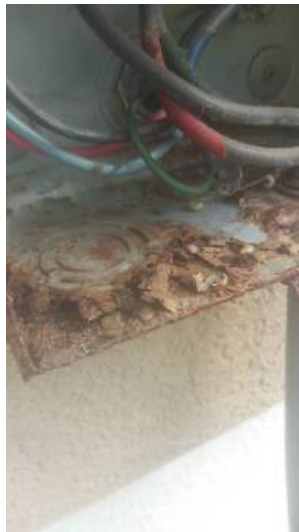
AC Service Disconnect

- The electrical service disconnect for the air conditioning condenser was damaged at panel housing. A qualified contractor should evaluate and repair/replace as necessary.

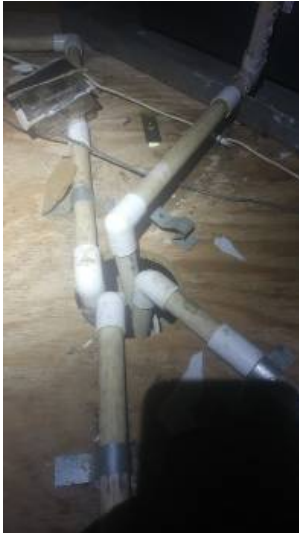
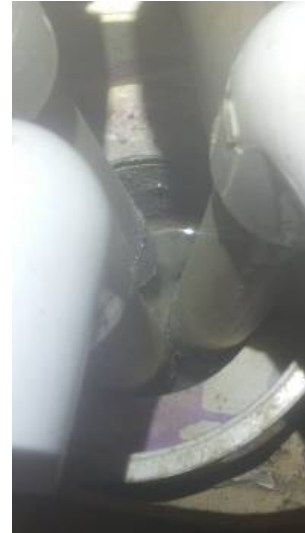
Condensate

- all for condensate lines dispense into a drain on the left side of the building. The drain appears to be full have a qualified contractor repair.

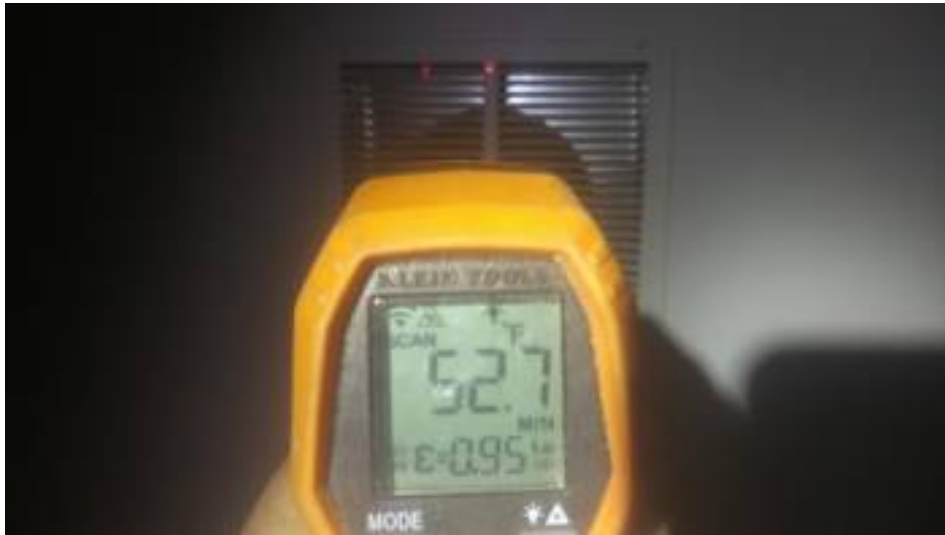
AC Operational

- The air conditioning system operated appropriately. A air conditioning system can be checked for performance by inspecting the air temperature going in the return and the air temperature coming out the supply, called (Delta T) . A system should have a 14-28 degree drop from the warmer air going in the return to the colder air coming out the supply. The temperature drop at this unit is 16 . This is acceptable operation.

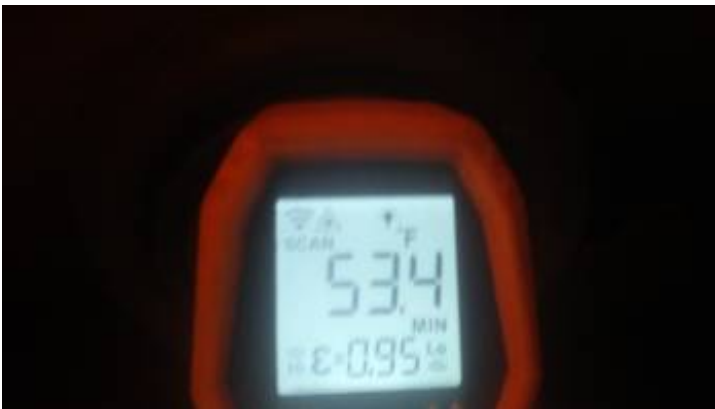
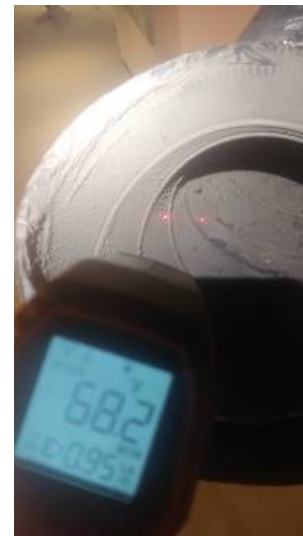
AC Operational

- The air conditioning system operated appropriately. A air conditioning system can be checked for performance by inspecting the air temperature going in the return and the air temperature coming out the supply, called (Delta T) . A system should have a 14-28 degree drop from the warmer air going in the return to the colder air coming out the supply. The temperature drop at this unit is 15 . This is acceptable operation.

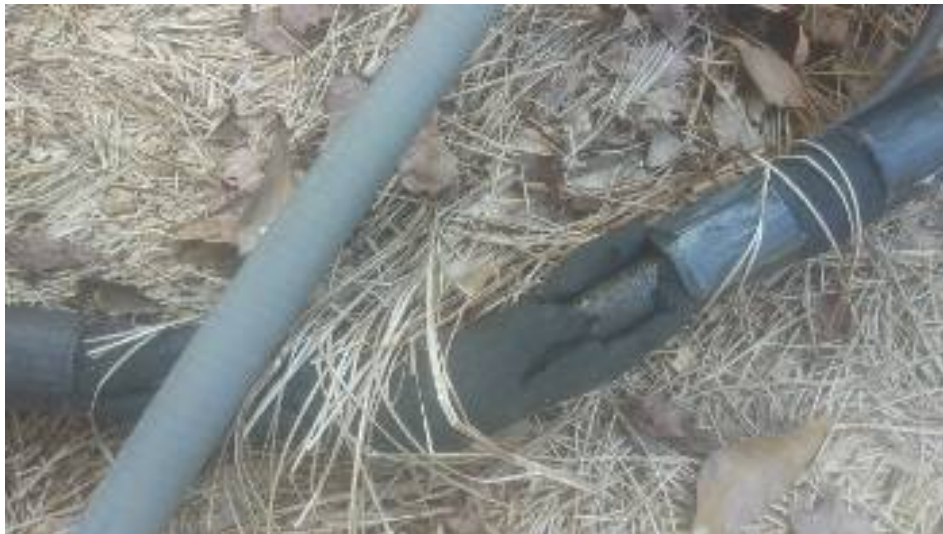
AC Refrigerant Lines

- The air-conditioner refrigerant suction line (large, insulated) has damaged or missing insulation in areas. A qualified contractor should evaluate and repair/replace as necessary.

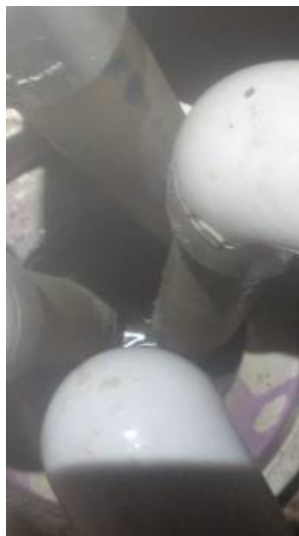
- all condensate on the lift 4 units are running into the same drain and it appears to be full have a qualified contractor repair.
