PROPERTY INSPECTION REPORT

555 Sample Address

Inspection Prepared For: Sample Commercial Inspection

Date of Inspection: 8/18/2018

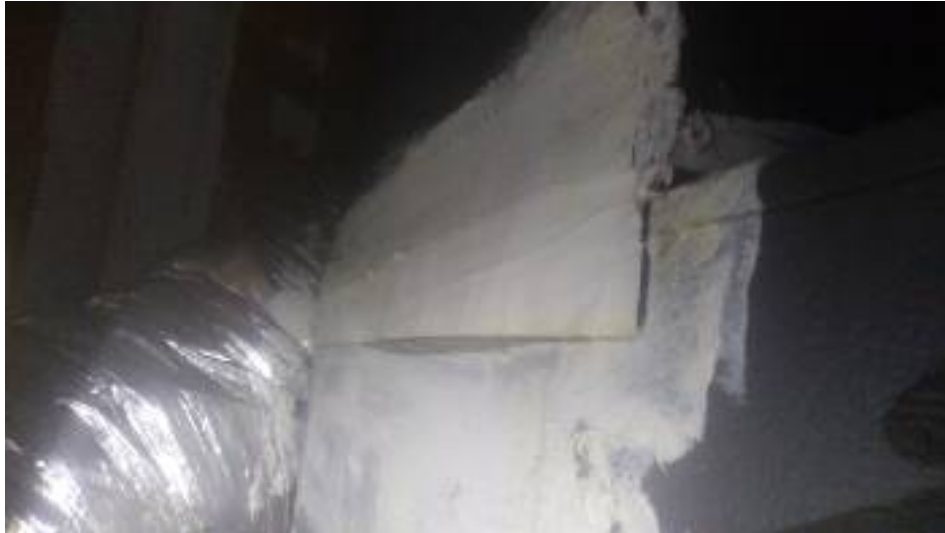
- tape is pulling loose around the ductwork have a qualified contractor repair

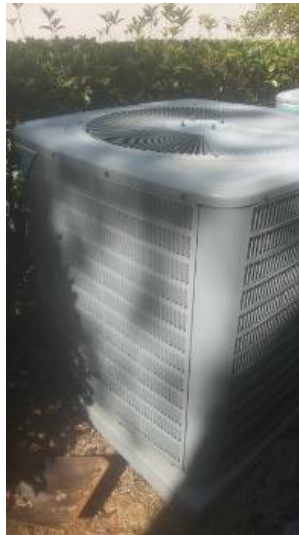
- The air-conditioner refrigerant suction line (large, insulated) has damaged or missing insulation in areas. A qualified contractor should evaluate and repair/replace as necessary.

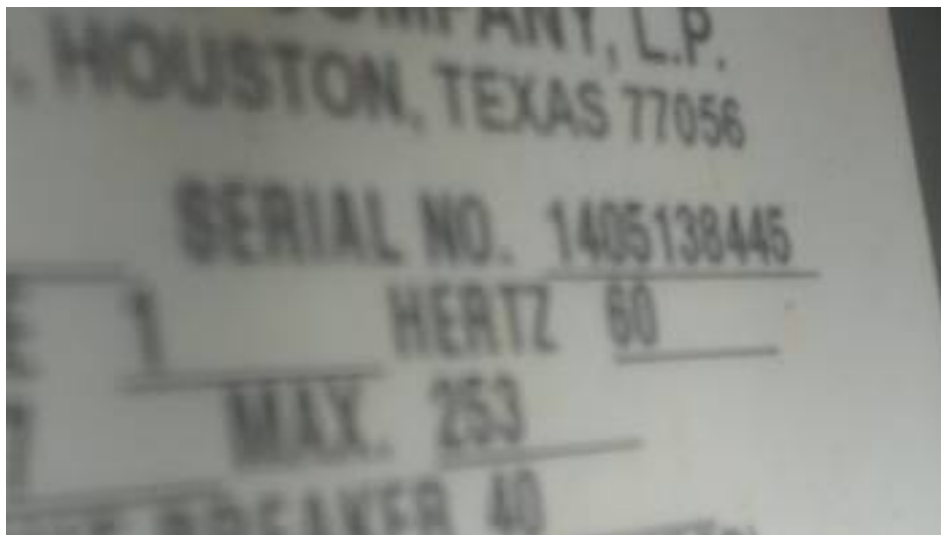
• I observed vegetation around the exterior cooling unit. Vegetation was too close to the unit, which can limit heat dissipation and limit effectiveness. Recommend cutting back vegetation to help improve performance.

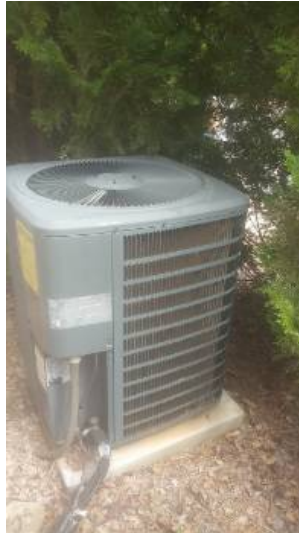
- they are run underground have a qualified contractor evaluate and or repair

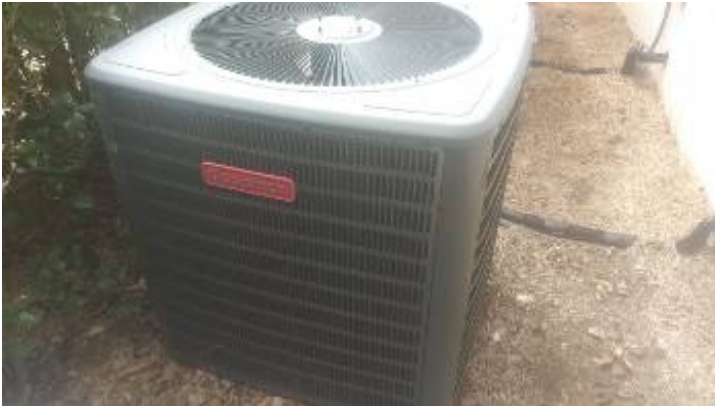
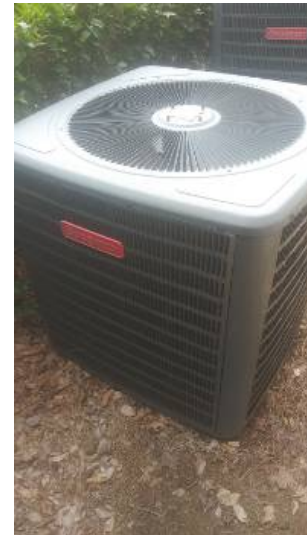
AC Compressor

- The air-conditioner compressor exterior cabinet appeared to be in serviceable condition at the time of the inspection.

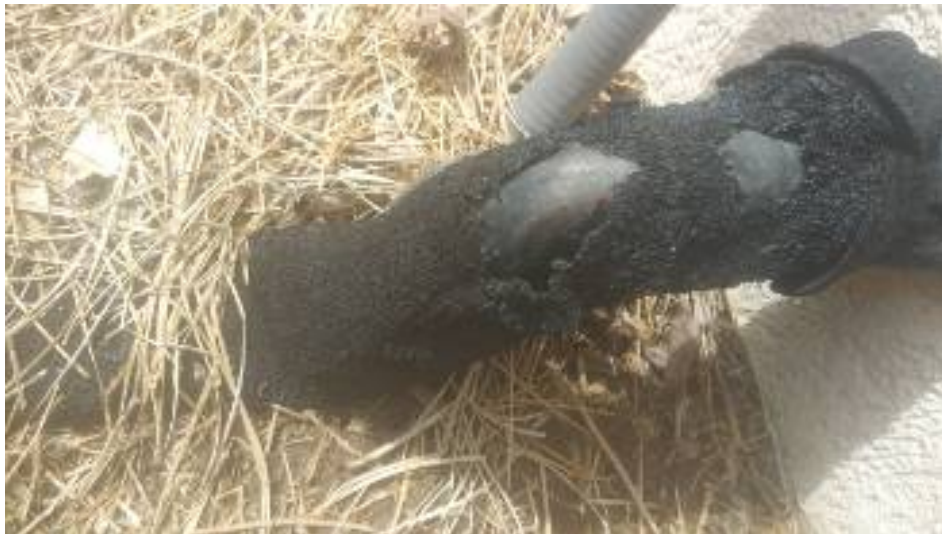
AC Refrigerant Lines

- The air-conditioner refrigerant suction line (large, insulated) has damaged or missing insulation in areas. A qualified contractor should evaluate and repair/replace as necessary.

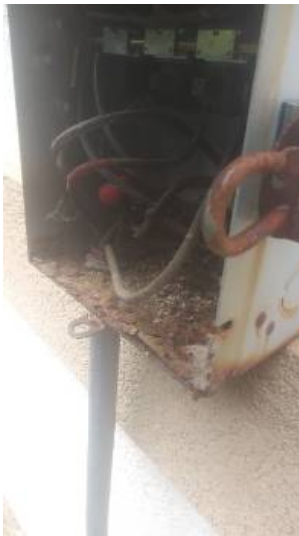
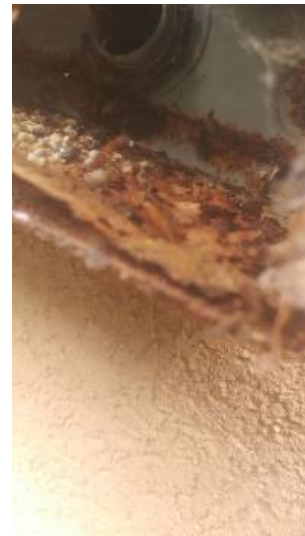
AC Service Disconnect

- The electrical service disconnect for the air conditioning condenser was damaged at panel housing. A qualified contractor should evaluate and repair/replace as necessary.

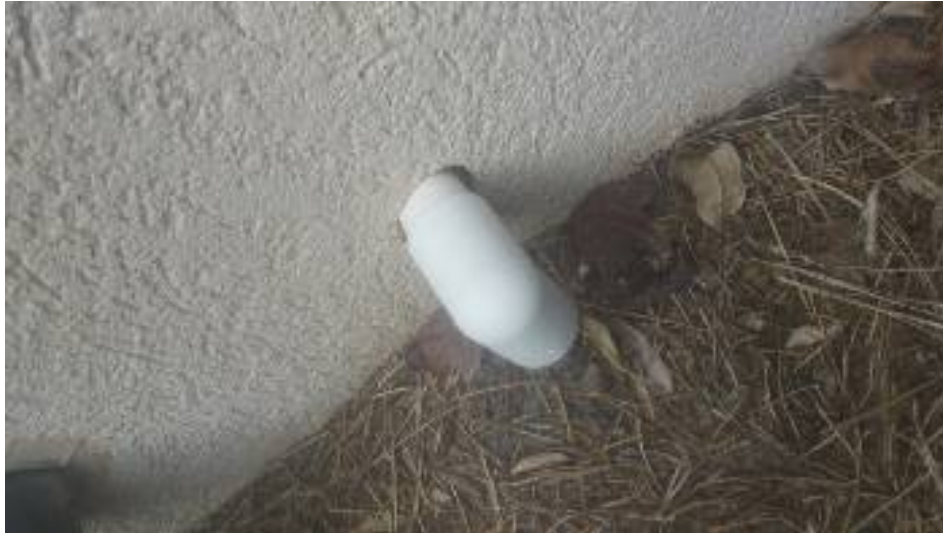
Condensate

- The condensate discharge pipe should be extended so that the water is diverted far enough away from the foundation. A qualified contractor should evaluate and repair or replace as necessary.

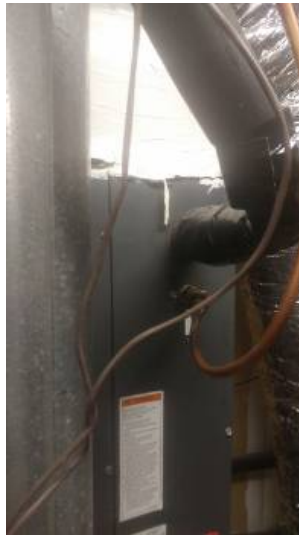
AC Evaporative Coils

- The air conditioning system evaporator coils were located inside furnace ductwork and were not accessible for inspection.

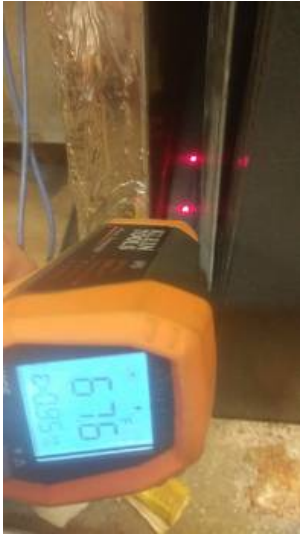
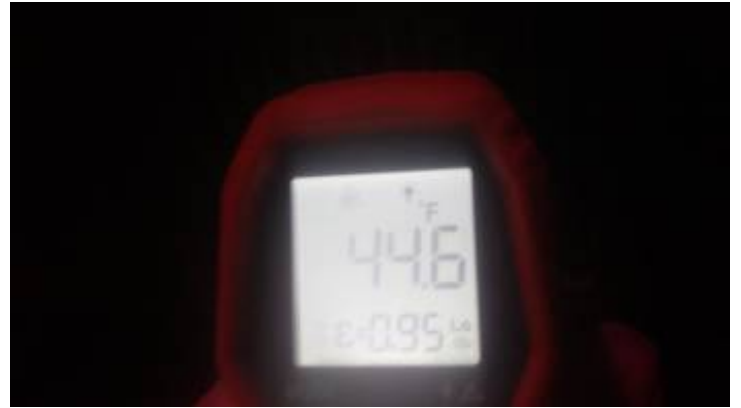
AC Operational

- The air conditioning system operated appropriately. A air conditioning system can be checked for performance by inspecting the air temperature going in the return and the air temperature coming out the supply, called (Delta T) . A system should have a 14-28 degree drop from the warmer air going in the return to the colder air coming out the supply. The temperature drop at this unit is 23 . This is acceptable operation.

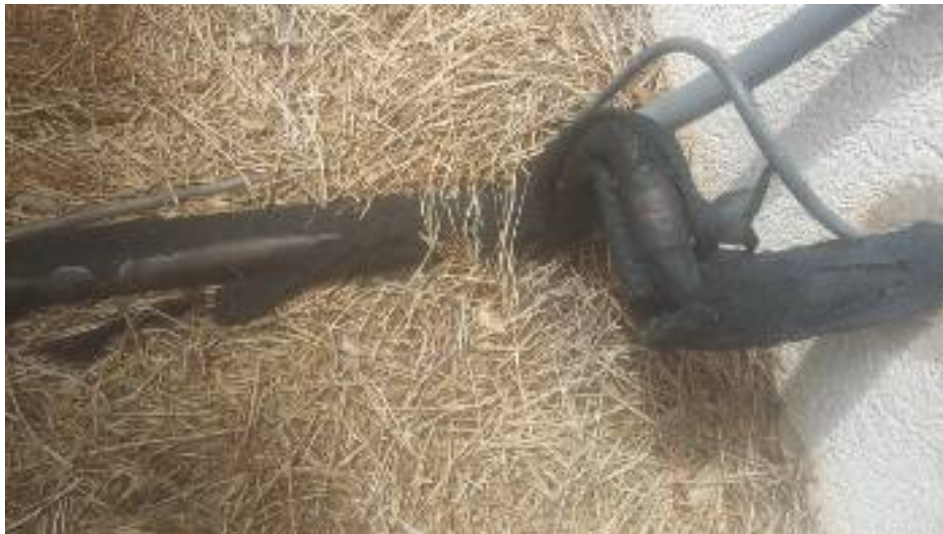
AC Refrigerant Lines

- The air-conditioner refrigerant suction line (large, insulated) has damaged or missing insulation in areas. A qualified contractor should evaluate and repair/replace as necessary.

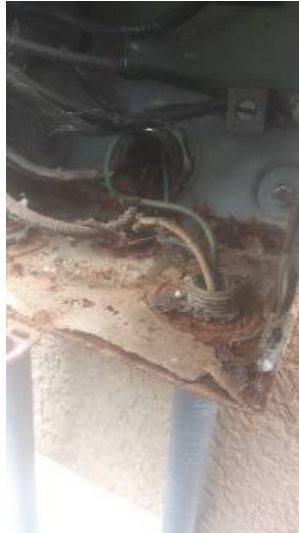
AC Service Disconnect

- The electrical service disconnect for the air conditioning condenser was damaged at panel housing. A qualified contractor should evaluate and repair/replace as necessary.

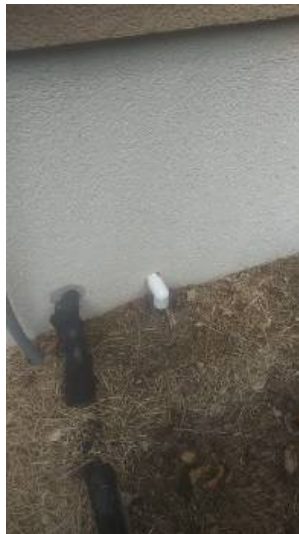
Condensate

- The condensate discharge pipe should be extended so that the water is diverted far enough away from the foundation. A qualified contractor should evaluate and repair or replace as necessary.

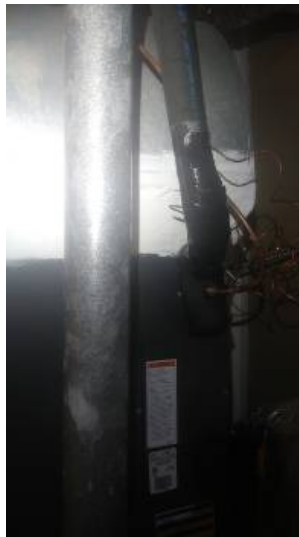
AC Evaporative Coils

- The air conditioning system evaporator coils were located inside furnace ductwork and were not accessible for inspection.

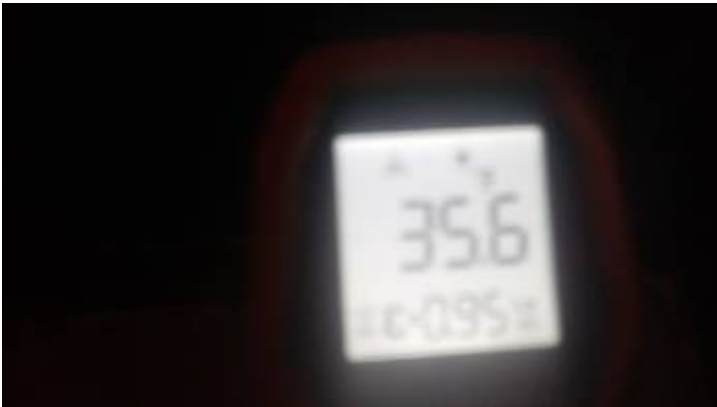
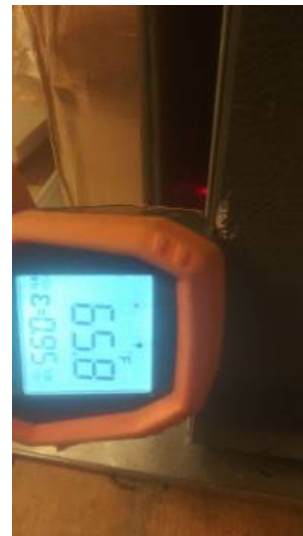
AC Operational

- The air conditioning system operated appropriately. A air conditioning system can be checked for performance by inspecting the air temperature going in the return and the air temperature coming out the supply, called (Delta T) . A system should have a 14-28 degree drop from the warmer air going in the return to the colder air coming out the supply. The temperature drop at this unit is 30 . This is acceptable operation.

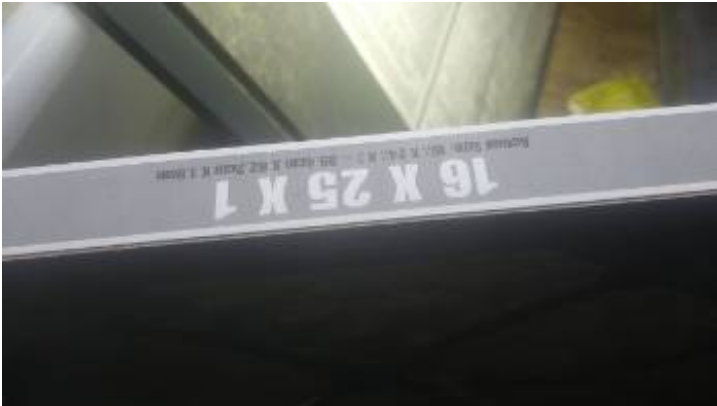
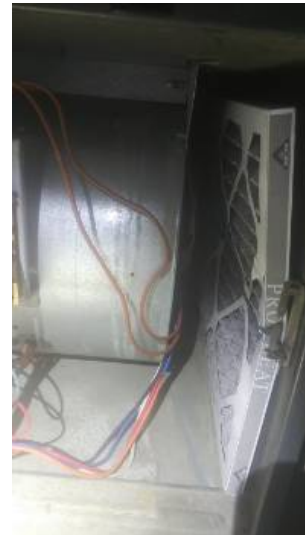
Air Filter

• The HVAC system was equipped with an air filter. It was reasonably clean and properly secured into position.

• the air filters beside the blower. 16x25x1

The filter itself is a little bent have a qualified contractor repair

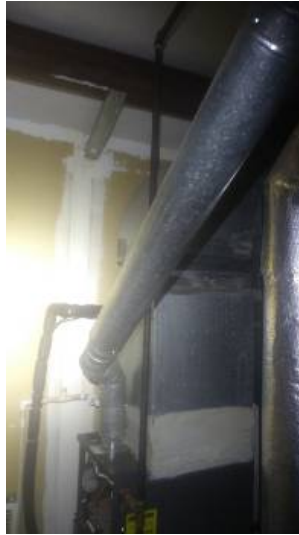
Combustion Air Supply

- The **combustion air** supply for this appliance was not present. A qualified contractor should evaluate and make necessary corrections according to current standards. Combustion air provides the oxygen needed for the safe and efficient operation of fuel burning appliances. An adequate supply of fresh air around all fuel burning appliances with open combustion compartments is vital for their safe operation. Years ago, the air could come from inside or outside the building, however, more recent standards prefer for combustion air to come from the outside only.

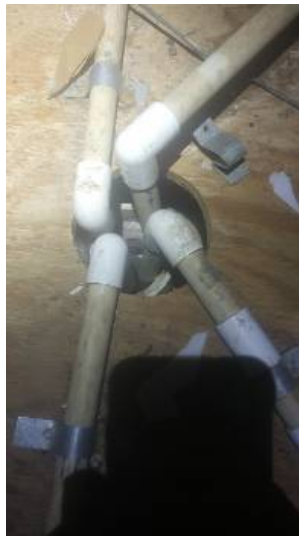
Condensate

- the condensate for all of the units on the left side of the building have been run into a drain that appears to be full have a qualified contractor repair

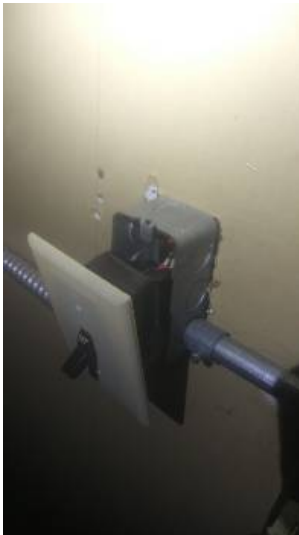
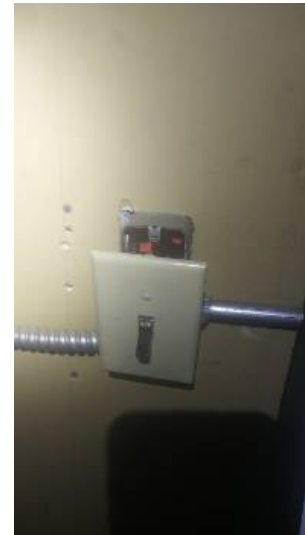
Heating System Service Disconnect

- the disconnect is not secure have a qualified contractor repair

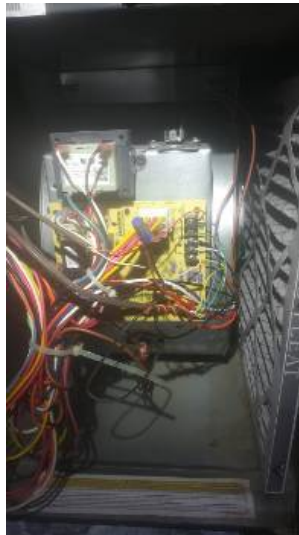
Combustion Air Supply

- the light is not fully operational have a qualified contractor repair
- The combustion air supply for this appliance was not present. A qualified contractor should evaluate and make necessary corrections according to current standards. Combustion air provides the oxygen needed for the safe and efficient operation of fuel burning appliances. An adequate supply of fresh air around all fuel burning appliances with open combustion compartments is vital for their safe operation. Years ago, the air could come from inside or outside the building, however, more recent standards prefer for combustion air to come from the outside only.

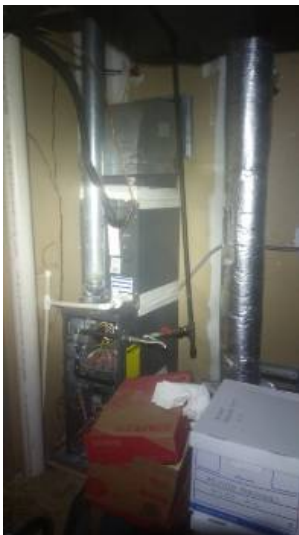
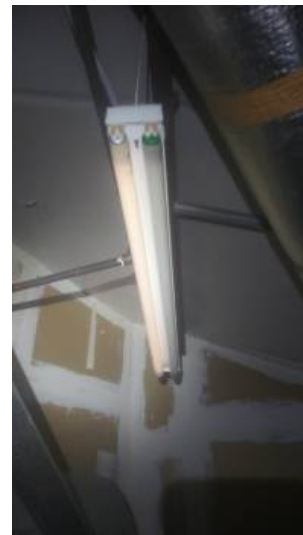
Also the light is not fully operational

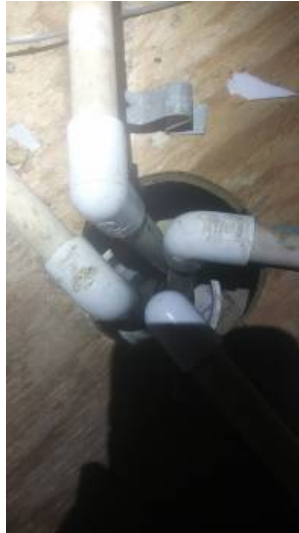
Condensate

- all four systems on the left side the condensation runs into a pipe that appears to be full of a qualified contractor repair

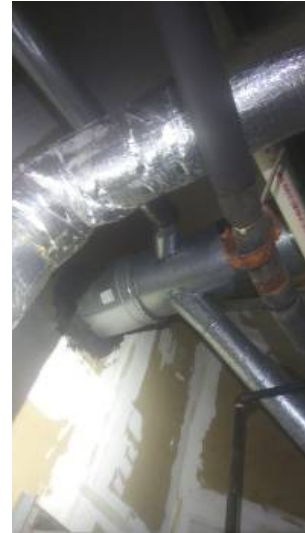
Gas Supply Shut-Off Valve

- gas supply does not appear to be well secured have qualified contractor repair

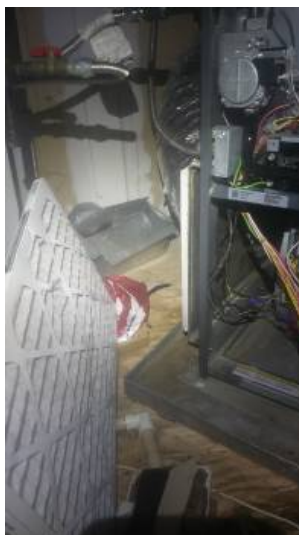
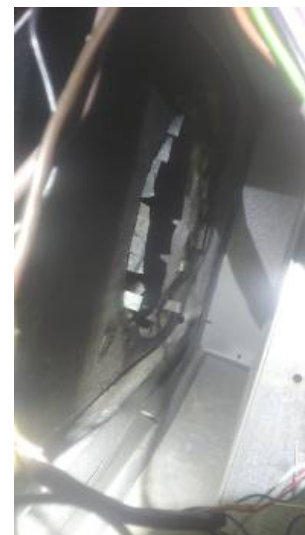
Air Filter

• there are two filters the filter on the left side is difficult to replace have a qualified contractor repair. 16x25x1

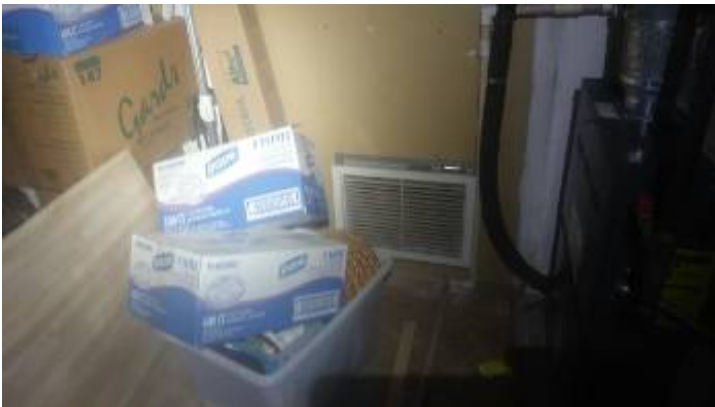
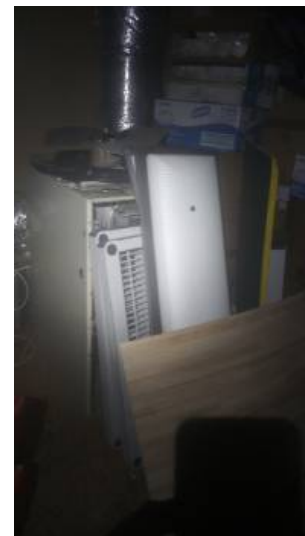
Combustion Air Supply

- there are a lot of items in this room and it is difficult to tell if there is Air Supply in here or not have a qualified contractor repair

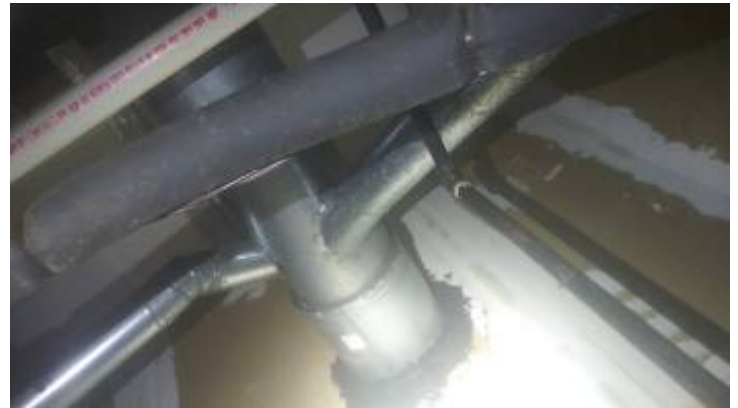
Gas Supply Shut-Off Valve

- secure the gas supply on all the furnaces.

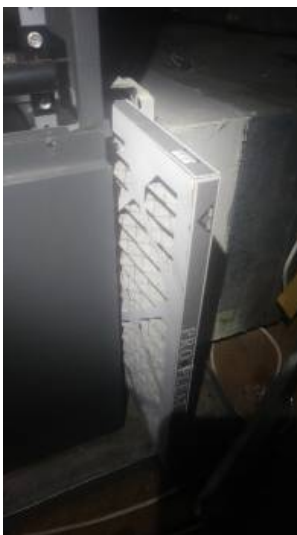
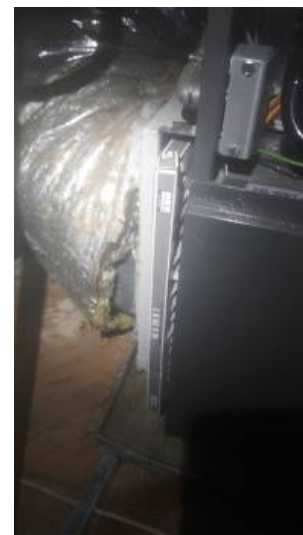
Air Filter

- the filter on the left side there are two filters the one on the left side is difficult to get in and out have a qualified contractor repair. 16x25x1

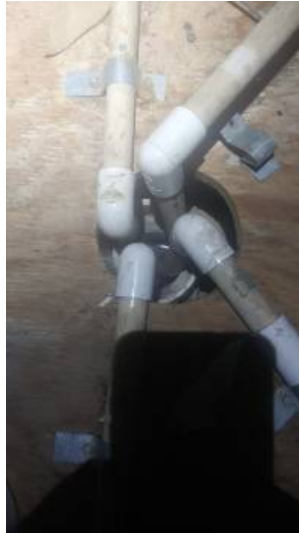
Condensate

- all of the condensate on the left side of the building runs into a pipe that appears to be full have a qualified contractor repair

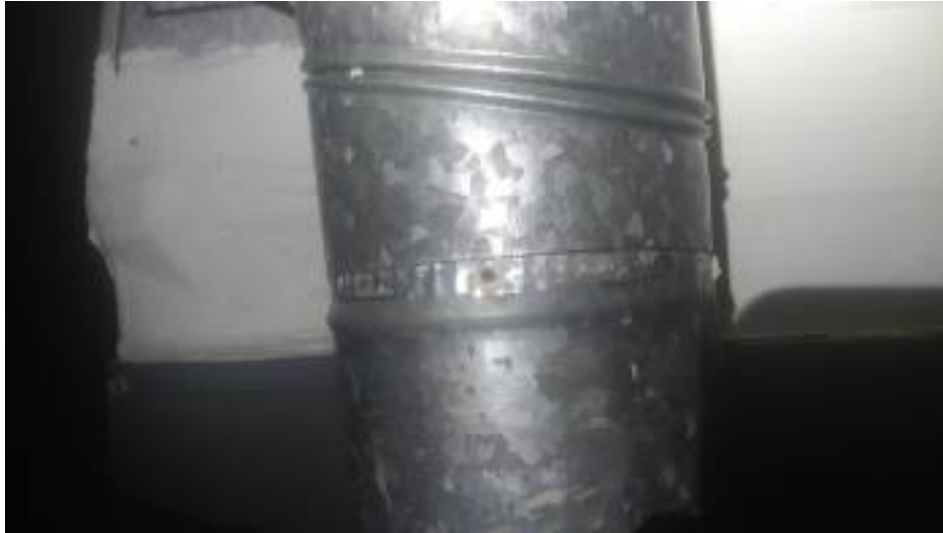
Exhaust Flue

- the exhaust flue appears not to be attached well have a qualified contractor repair

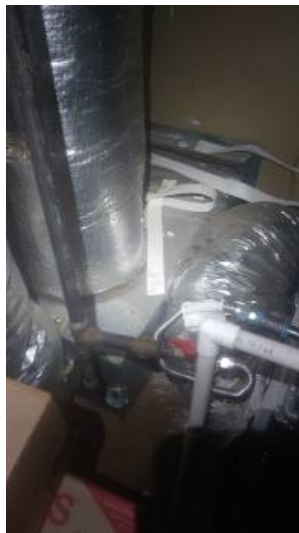
Gas Supply Shut-Off Valve

- have a qualified contractor secure the gas piping

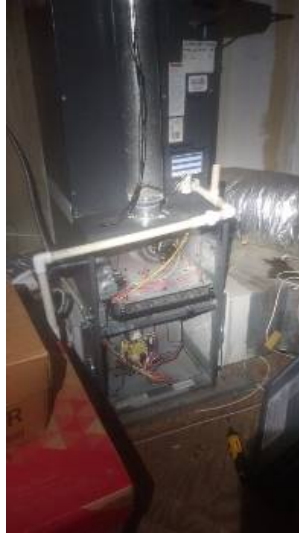
Heating System Cabinet

- The furnace cabinet exterior and interior appeared to be in serviceable condition at the time of the inspection.

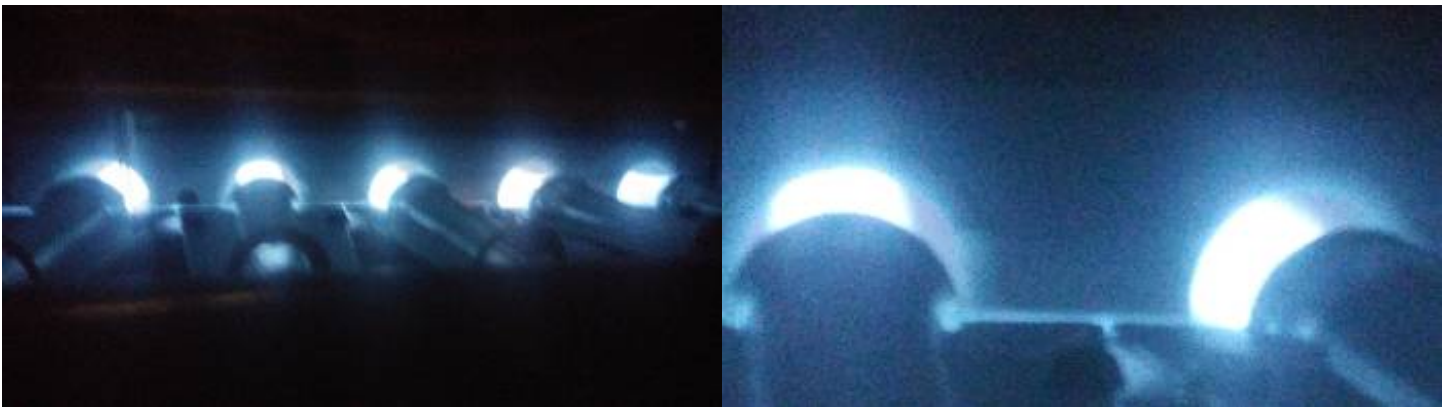
Heating System Operation

- The furnace was inspected and was operational at the time of the inspection.

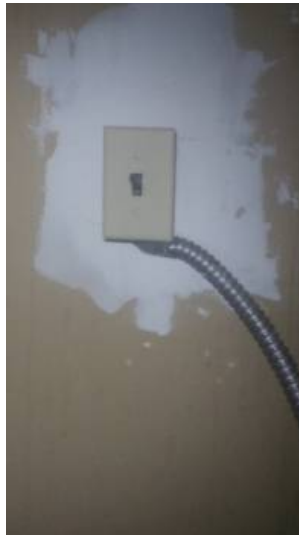
Heating System Service Disconnect

- The service disconnect was within sight of the heating system. Although it was not operated, it appeared to be in serviceable condition at the time of the inspection.

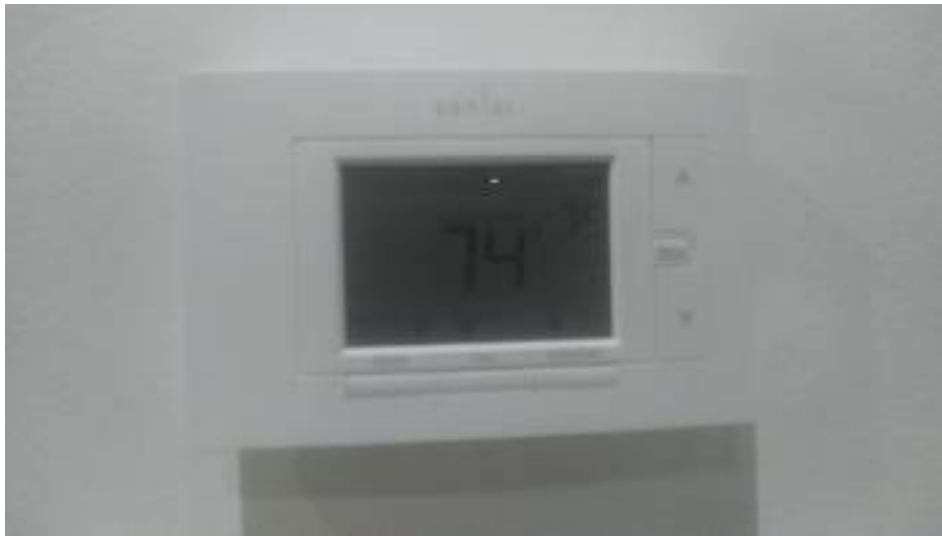
Thermostat Location: Sanctuary by Door

- The thermostat(s) was installed at a location in the property, which appears to be adequate to operate the HVAC system efficiently. The thermostat(s) was fastened securely to the wall, activated the HVAC unit, and appeared to be in serviceable condition.

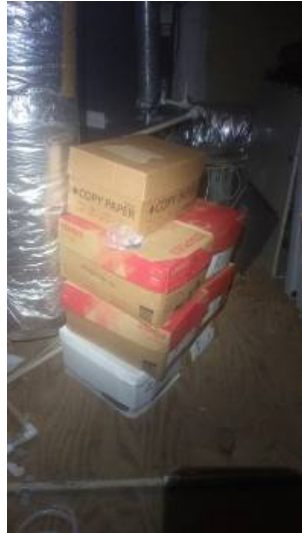
Flammable Storage

- All storage that is flammable and combustible must be orderly and separated from heaters or any appliances/equipment that can create heat or a spark. This distance can be decreased by having or adding shielding that will not allow heat or spark to pass through. Flammables must not be stored in exits, boiler rooms, mechanical rooms, electrical equipment room or any room creating heat or spark.

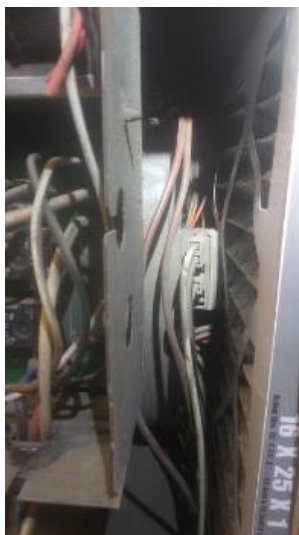
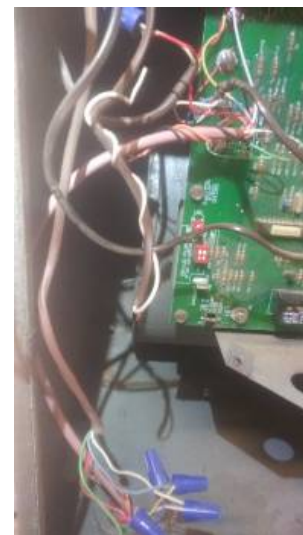
Blower

• The blower fan was dirty and doesn't appear to be maintained. Have a qualified contractor evaluate and repair/clean the system.

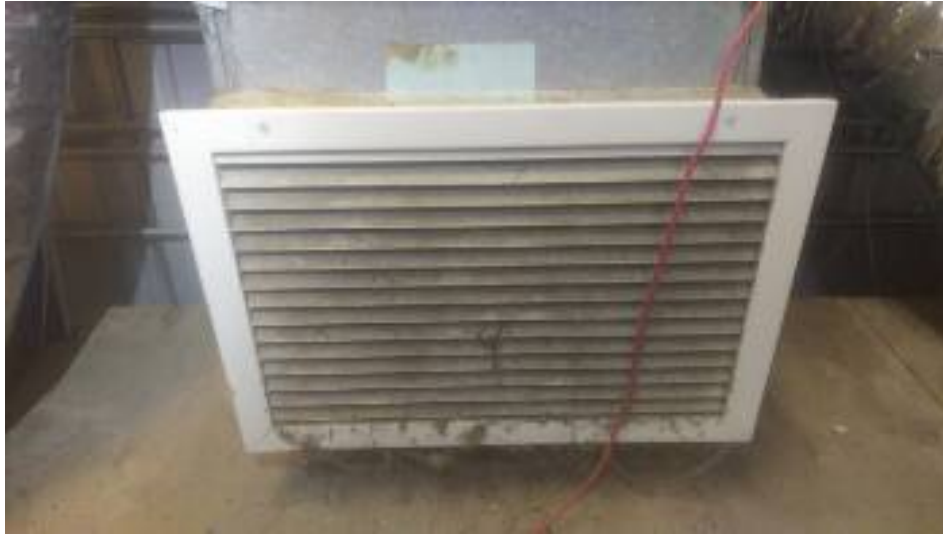
Combustion Air Supply

• The combustion air supply for this appliance was present. Combustion air provides the oxygen needed for the safe and efficient operation of fuel burning appliances. An adequate supply of fresh

air around all fuel burning appliances with open combustion compartments is vital for their safe operation. Hazardous situations do not have a grandfather clause.

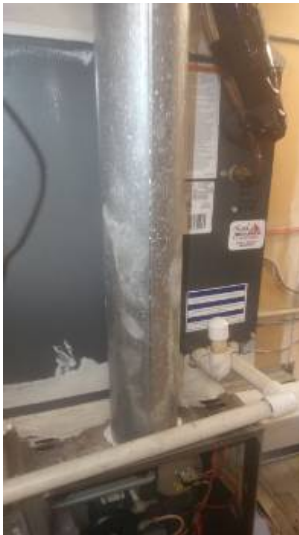
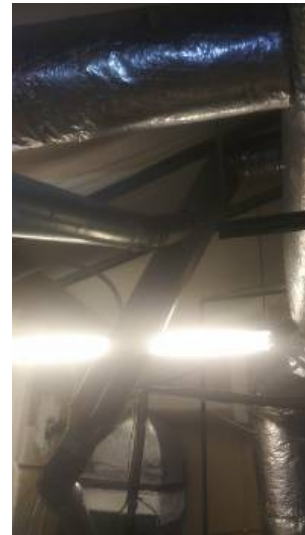
Exhaust Flue

- The heating system exhaust flue had proper connections, slope and clearance from combustibles.

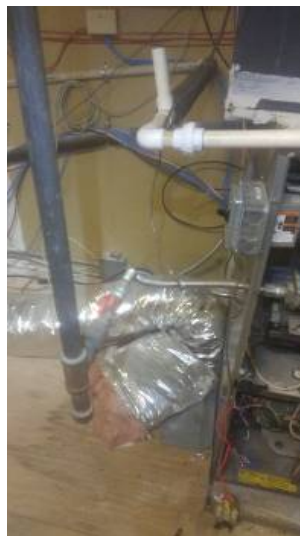
Gas Supply Shut-Off Valve

- gas supply should be secured and there is a flexible pipe entering the furnace this must be a solid pipe have a qualified contractor repair

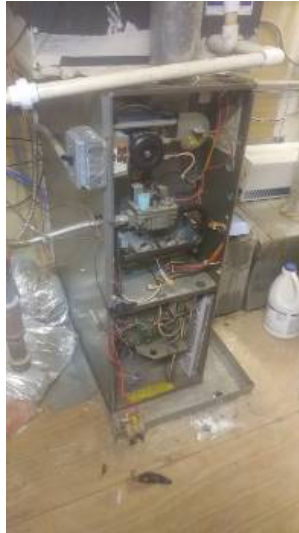
Heating System Cabinet

- The heating system cabinet doesn't appear to be well maintained. Have a qualified contractor evaluate and repair or replace as necessary.

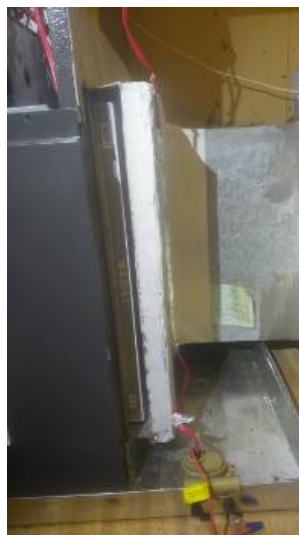
Air Filter

• The HVAC system was equipped with an air filter. It was reasonably clean and properly secured into position.

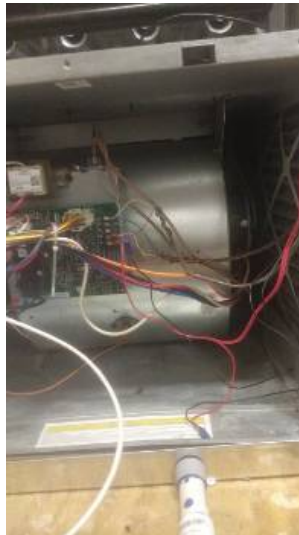
Blower

• The heating system blower appeared to operate in a satisfactory manner at the time of the inspection, it was fairly clean and appeared to be maintained.

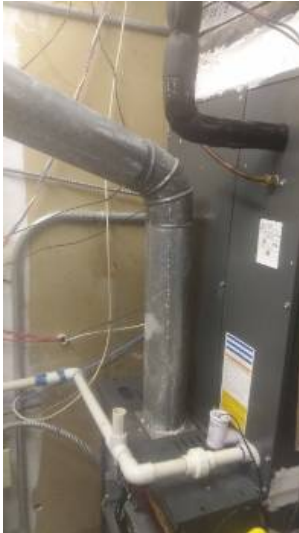
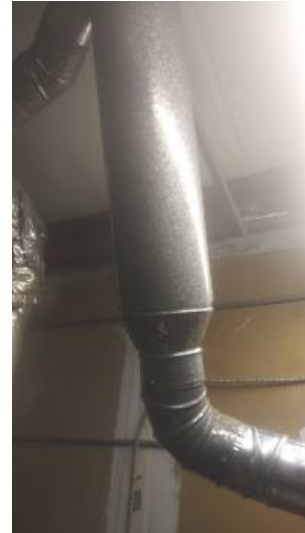
Exhaust Flue

- The heating system exhaust flue had proper connections, slope and clearance from combustibles.

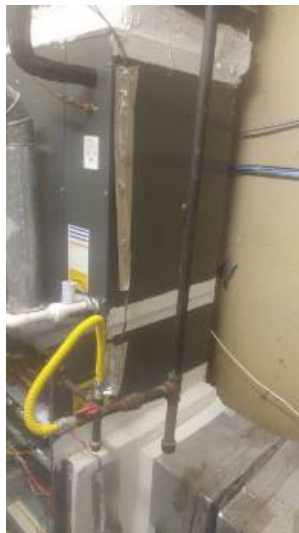
Gas Supply Shut-Off Valve

- have a qualified contractor secure the gas line

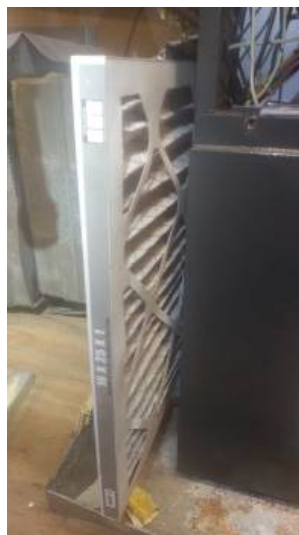
Air Filter

• The HVAC system was equipped with an air filter. It was reasonably clean and properly secured into position.

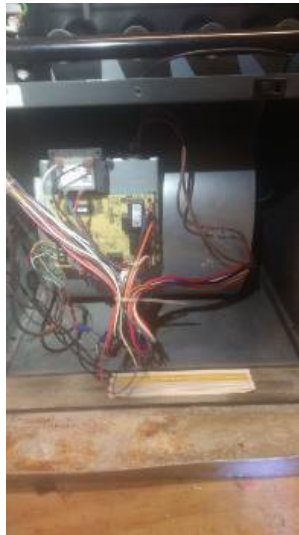
Blower

• The heating system blower appeared to operate in a satisfactory manner at the time of the inspection, it was fairly clean and appeared to be maintained.

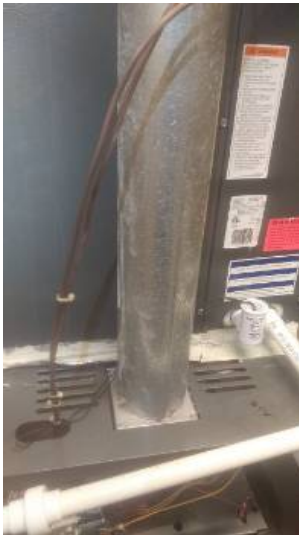
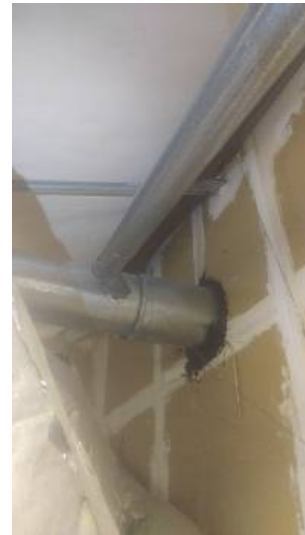
Exhaust Flue

- The heating system exhaust flue had proper connections, slope and clearance from combustibles.

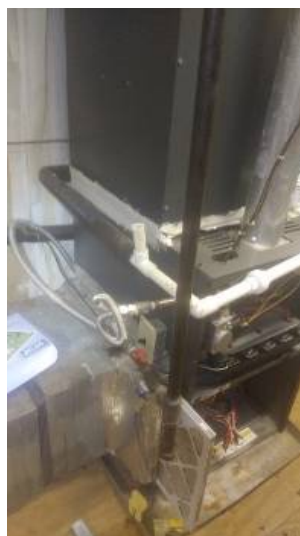
Gas Supply Shut-Off Valve

- gas supply line needs to be braced

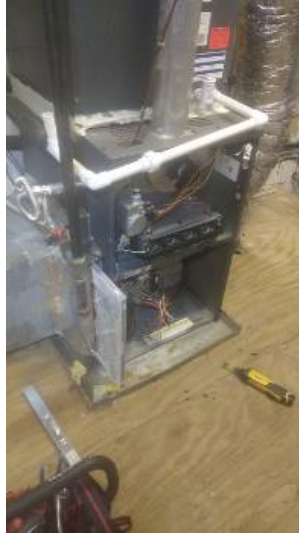
Heating System Cabinet

- The furnace cabinet exterior and interior appeared to be in serviceable condition at the time of the inspection.

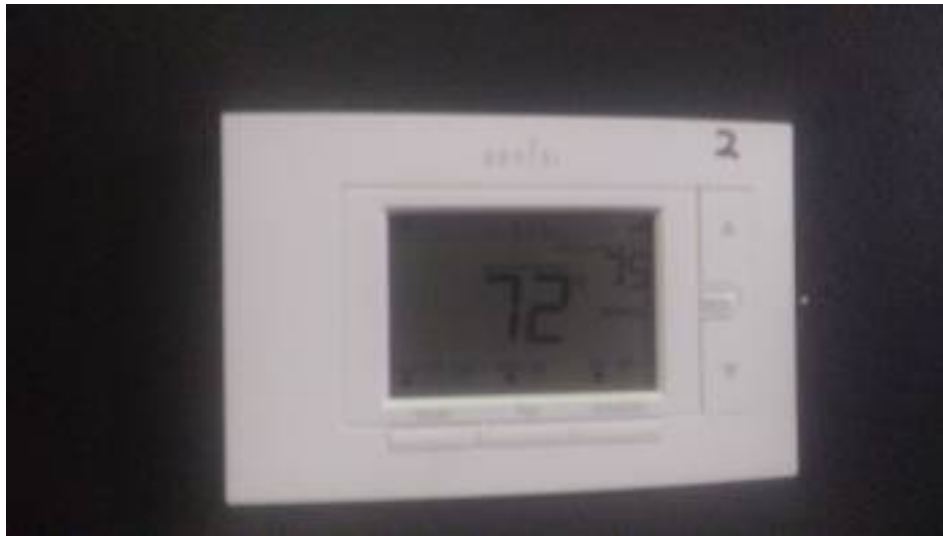
- The thermostat(s) was installed at a location in the property, which appears to be adequate to operate the HVAC system efficiently. The thermostat(s) was fastened securely to the wall, activated the HVAC unit, and appeared to be in serviceable condition.

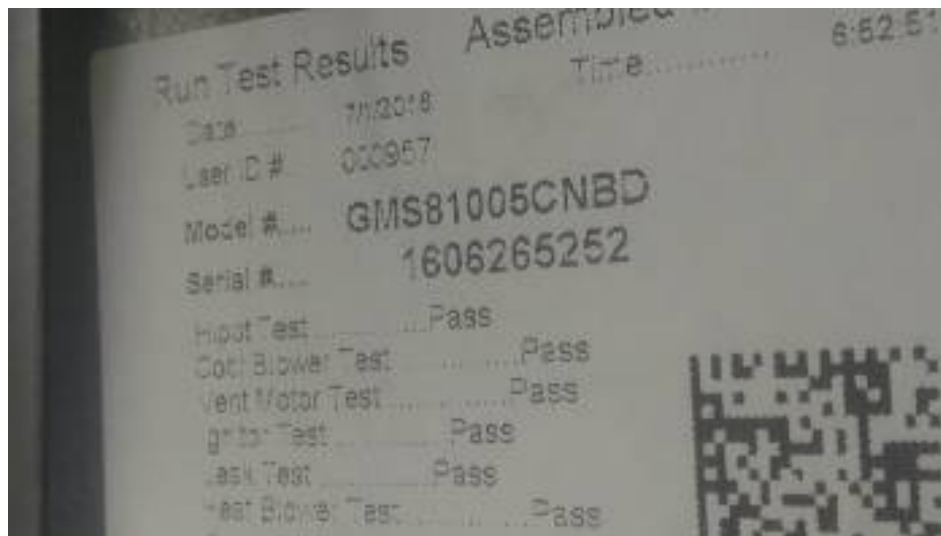
Heating Label Information: Information from the heating system data plate is shown in the photo and contains the manufacturer, serial number, size and date.

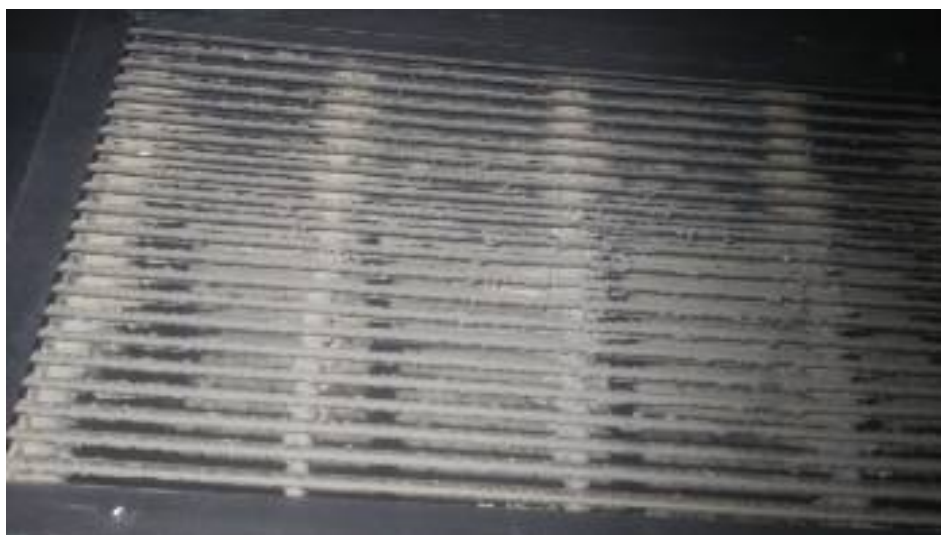
- mini return lines around the building or dirty have a qualified contractor clean the return ductwork

Many return lines are dirty

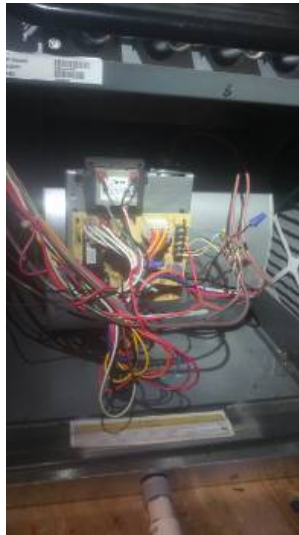
- The heating system blower appeared to operate in a satisfactory manner at the time of the inspection, it was fairly clean and appeared to be maintained.

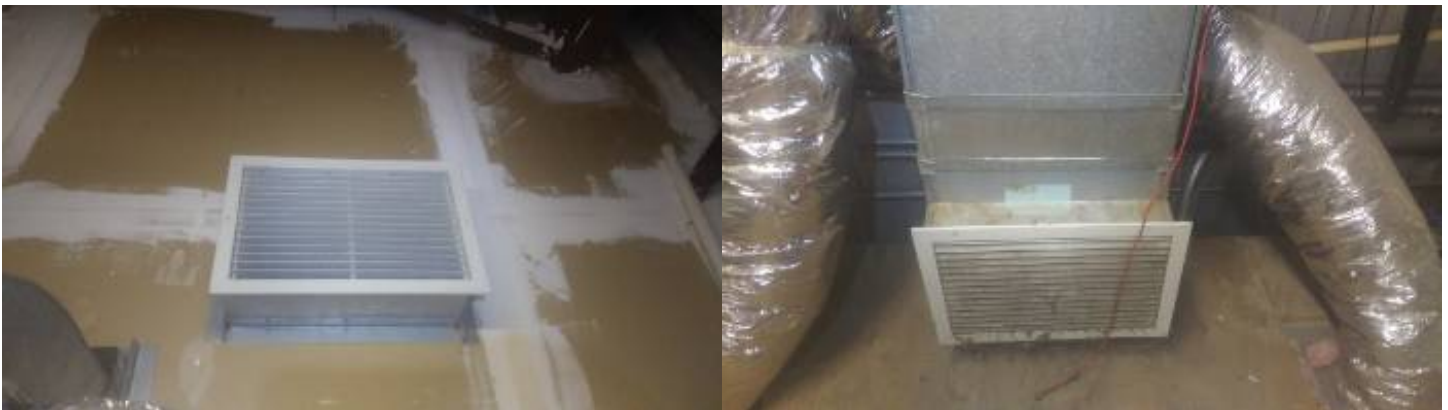
- The combustion air supply for this appliance was present. Combustion air provides the oxygen needed for the safe and efficient operation of fuel burning appliances. An adequate supply of fresh air around all fuel burning appliances with open combustion compartments is vital for their safe operation. Hazardous situations do not have a grandfather clause.

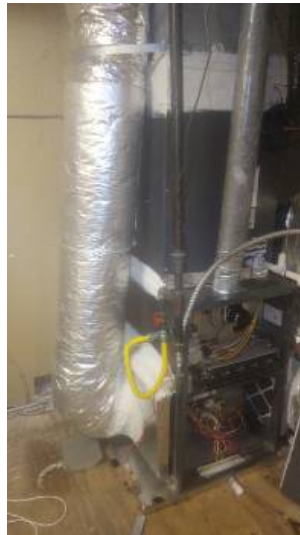
- The condensate discharge pipe should be extended so that the water is diverted far enough away from the foundation. A qualified contractor should evaluate and repair or replace as necessary.

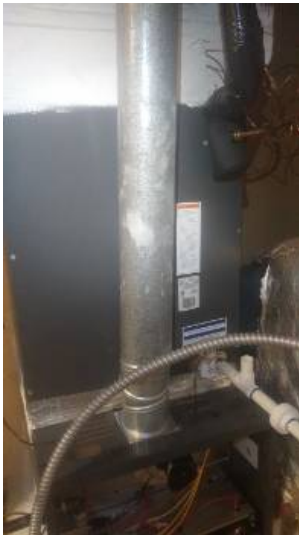
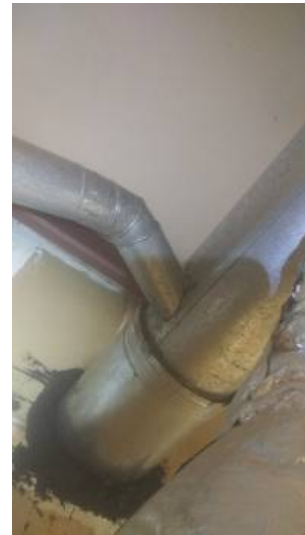
- The heating system exhaust flue had proper connections, slope and clearance from combustibles.

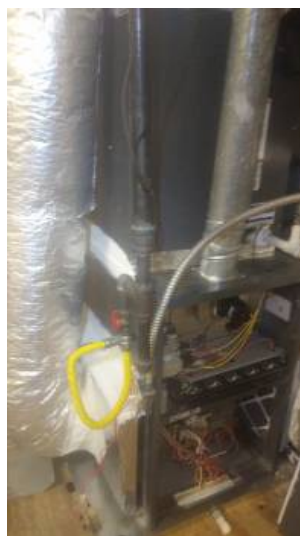
- have a qualified contractor secure the gas supply

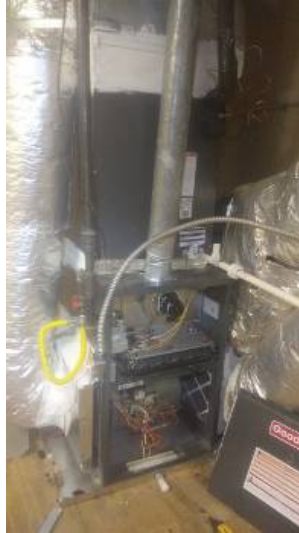
- The furnace cabinet exterior and interior appeared to be in serviceable condition at the time of the inspection.

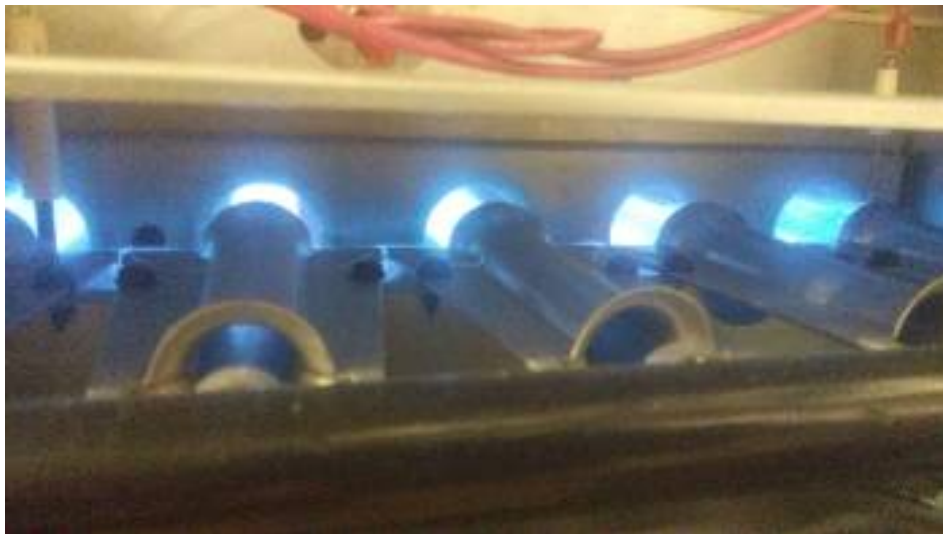
- The furnace was inspected and was operational at the time of the inspection.

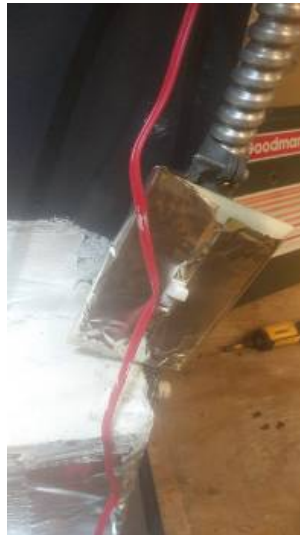
- The service disconnect was within sight of the heating system. Although it was not operated, it appeared to be in serviceable condition at the time of the inspection.

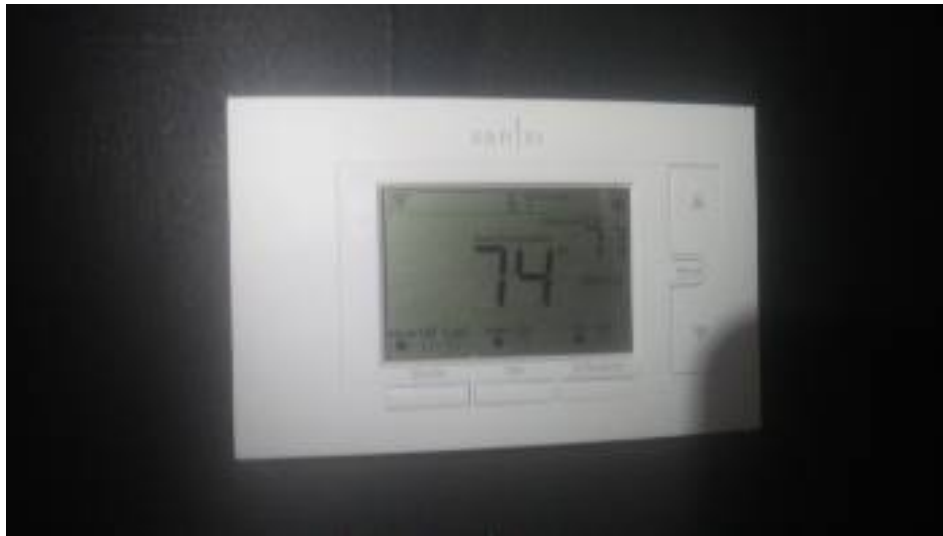
Thermostat Location: Left side of stage

- The thermostat(s) was installed at a location in the property, which appears to be adequate to operate the HVAC system efficiently. The thermostat(s) was fastened securely to the wall, activated the HVAC unit, and appeared to be in serviceable condition.
